An Historic Environment Survey of the Smallholdings

An Historic Environment Survey of the Smallholdings at Hart, Hartlepool

September 2010

TA 10/16

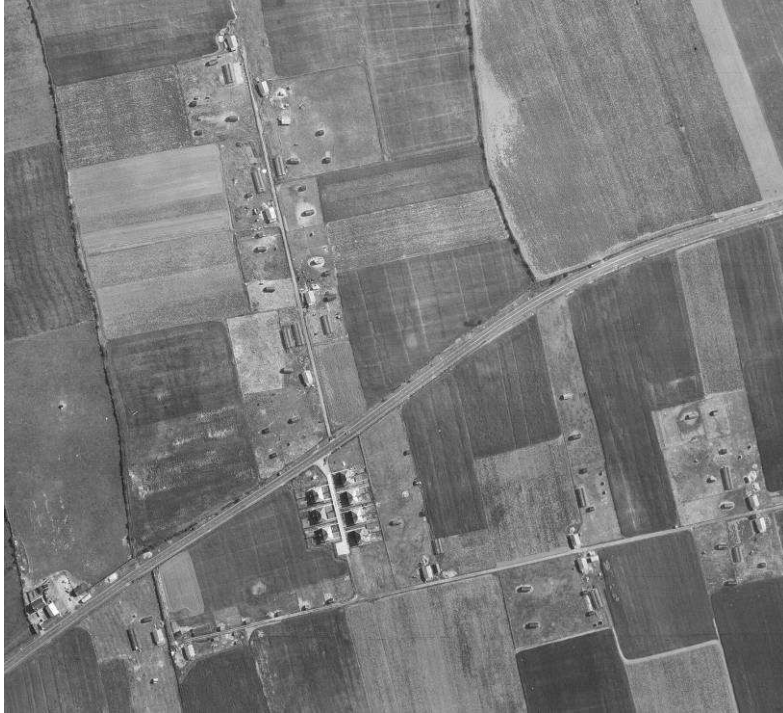
In 1948 the RAF photographed the whole of the UK and the photograph below of Nine Acres shows the range of structures involved in the smallholdings and how they were deployed.

**Figure 1: Nine Acres,
RAF Aerial Photograph
(RAF/58/B/59/5559,
English Heritage (NMR)
RAF Photography)**

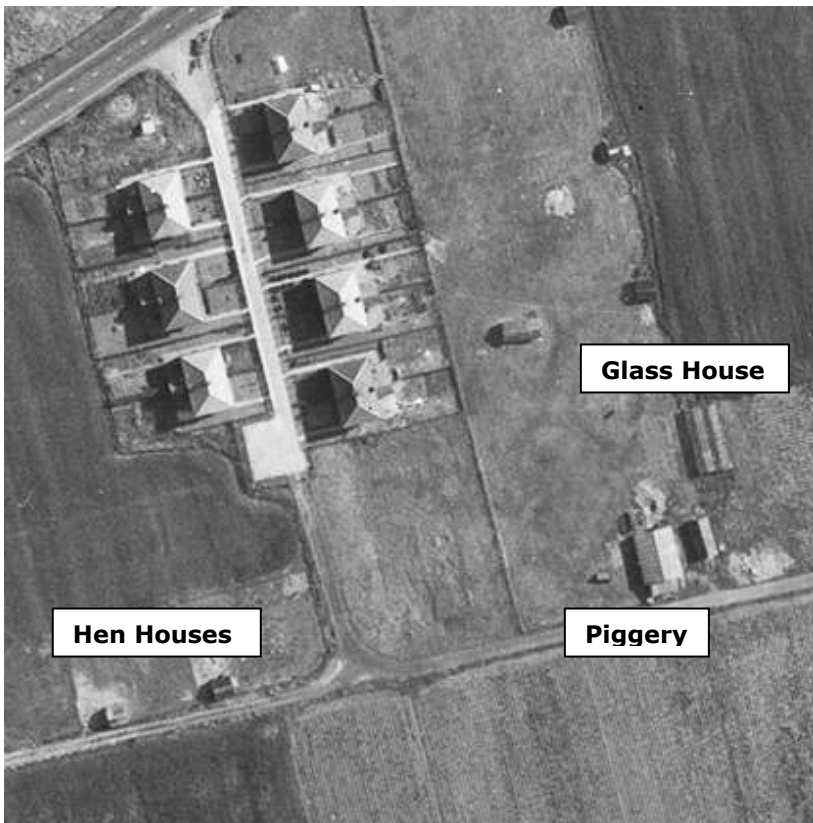
**Figure 2: Nine Acres,
detail of Buildings of
Smallholdings
(RAF/58/B/59/5559,
English Heritage (NMR)
RAF Photography)**

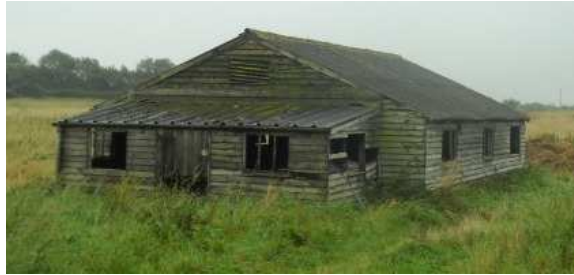
The piggeries were all of the same construction, comprising a timber frame based on a low brick wall and boarded with horizontal planking. They were originally roofed with boards and felt but this tended to be replaced with asbestos sheeting. The buildings were of a single storey with gable ends which might have single or double doors at one end. The other end had a 'lean to' arrangement across most of its width and this provided access to that end and a store for feed. There were usually three windows down each side, and a ventilator at the top of at least one of the gable ends. The 'lean to' had three windows along its length and one at the end opposite the doorway.

A number of the piggeries are now used for storage or have become derelict, none are used for their original purpose and a few have been converted to hold machinery or to accommodate cattle, although they seem again to have gone out of use.

Fig 6: Piggery, The Fens, Structure C/11

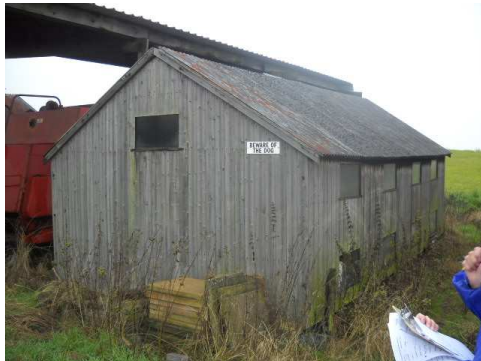
Hen Houses were numerous originally but only a few survive, mainly at The Fens (see Structure C16). They are single storey timber structures with

Fig 7: Hen House, The Fens, Structure C/13

There is a sliding door in one gable and both gables have a single light window

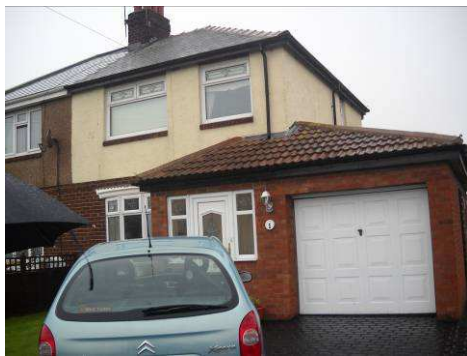
Fig 9: No 1 Burns Close

Two storey semi-detached house, square in plan with hipped roof of artificial slate. The building shares a chimney with the adjoining building (2 Burns Close). It is brick built with the first storey rendered, there is an extension to the south elevation to provide a front porch and this wraps round to the side to provide a

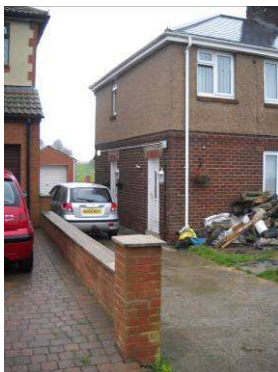
Fig 10: No 2 Burns Close

Adjoins B/01 and construction is the same. The window openings are original

position but contain double glazed windows. The building also retains the original side entrances, although with PVC doors.

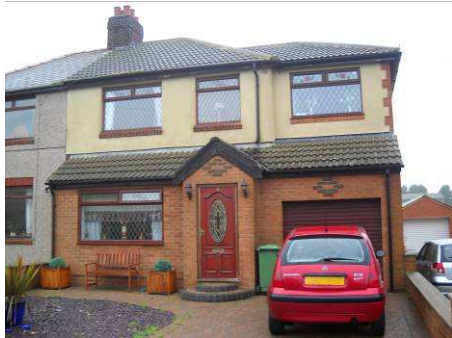
Fig 11: No 3 Burns Close

Two storey semi-detached house, brick built with first floor rendered at the front. The building has been extended to the front to provide additional living accommodation and an enclosed entrance porch. The extension wraps round to the side of the house

and increases to two storeys with garage to ground floor and additional living space. The main entrance to the building has been moved to the front. All windows are double glazed.

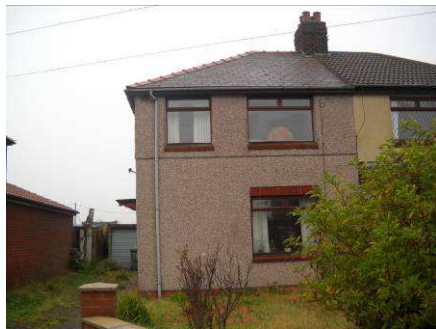
Fig 12: No 4 Burns Close

This adjoins No 3 Burns Close and is of the same construction, but fully rendered.

The original window openings have been kept but with double glazed windows, however only one of the original two side doors has been retained with its canopy.

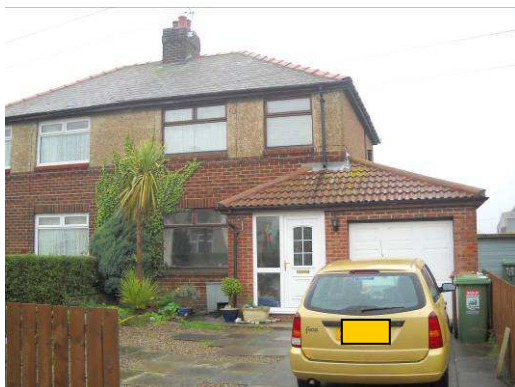
Fig 13: No 5 Burns Close

Two storey semi-detached house, brick built with pebble dash from mid first floor

level, pitched, hipped roof and shared chimney stack with No 6. The building has been extended to the front on the ground floor to provide an enclosed porch over an entrance to the house. The extension continues round to the side elevation to provide a single storey extension to accommodate a garage.

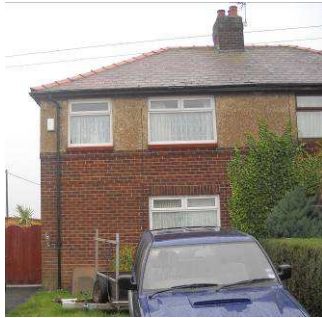
Fig 14: No 6 Burns Close

Construction is the same as 5 Burns Close, the original window openings have been retained as has one entrance door to the side of the building.

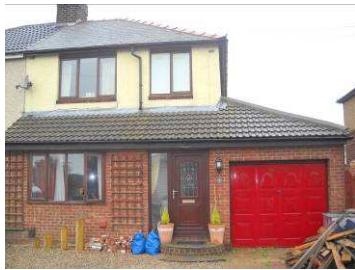
Fig 15: No 7 Burns Close

Two storey semi-detached house, adjoining B/08, square in plan with hipped roof.

Built in brick with rendered first floor and artificial slate roof. The original window openings on the front elevation have been retained and comprise one double window at ground floor level and one single and one double window at first floor.

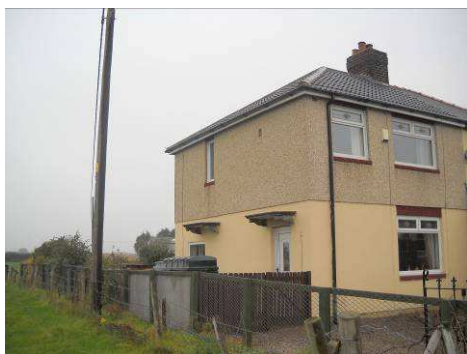
Fig 16: No 8 Burns Close

Construction is the same as B/07 except that the ground floor has been rendered.

The building has retained the original window openings, but with double glazing installed. A single side door remains, a second having been blocked up and a window installed to one side, however both original concrete canopies survive.

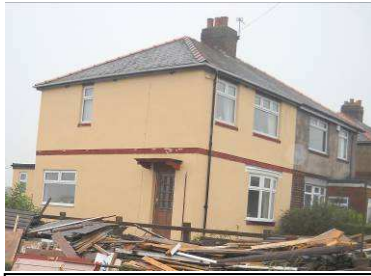
Fig 17: No 9 Burns Close

Two storey square semi-detached house with a pitched, hipped roof of artificial slate.

It shares a brick chimney stack with three pots with No 10 Burns Close. Brick built but fully rendered. Bay window inserted in original opening in front elevation, original openings now with double glazing at first floor. One of the original doors to the side elevation has been retained with canopy over. The rear door has

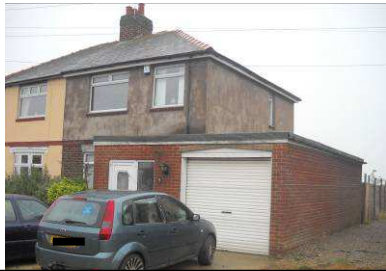
Fig 18: No 10 Burns Close

This adjoins A/09 and is constructed in the same way; however this is only rendered

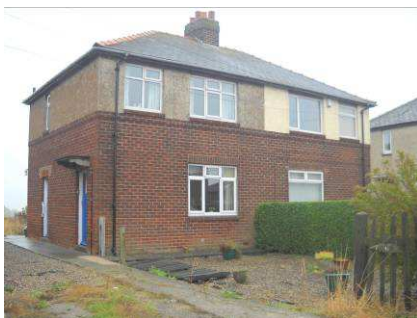
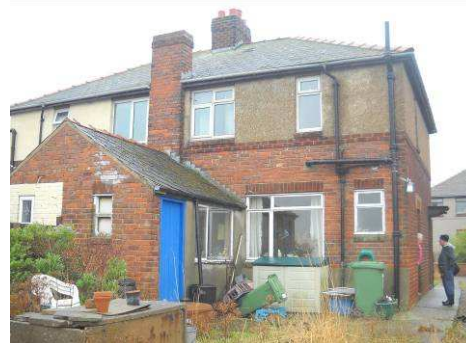
Two storey semi-detached dwelling house, square in plan with a hipped roof.

Fig 19: Front of No 11 Burns Close

Fig 20: Rear of No 11 Burns Close

Built in brick with pebble dashing from string course at middle of first floor. It shares a chimney stack with 12 Burns Close. The building retains all its original openings but with replacement windows and doors and has lost the concrete canopy over the rear,

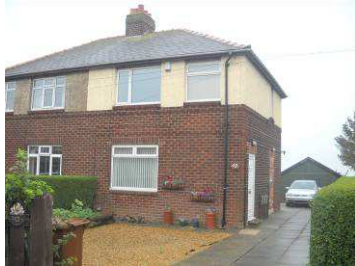
Fig 21: No 12 Burns Close

Construction is the same as A/11. It retains all its original opening apart from one of the side doors, which has been bricked up; it has lost the concrete canopies over the doors. Windows have been replaced with double glazing.

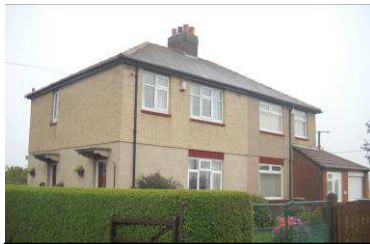
Fig 22: No 13 Burns Close

Two storey semi-detached dwelling house, square in plan with hipped roof. Brick built with slate roof. It is rendered at first floor level and shares a chimney stack with 14 Burns Close. It retains its original door and window opening although windows have been replaced with double glazing and new doors fitted. The canopies have been retained over the doors. The ground floor has been painted.

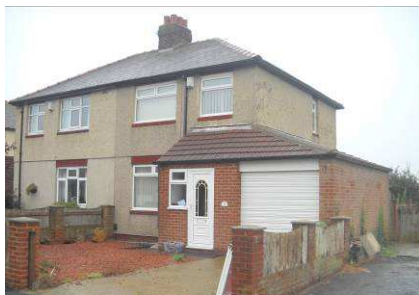
Fig 23: No 14 Burns Close

Construction is the same as A/13, but it has been pebble dashed all over. It has been extended to provide an enclosed porch to the front of the property and a garage to the side of the building.

The front and side elevations retain their original window openings but with replacement windows. The entrance to the property is now to the front through the extension.

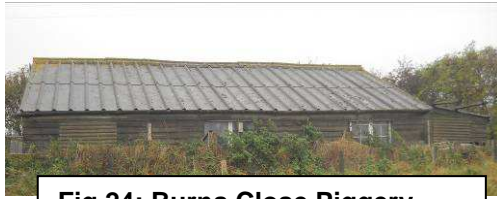
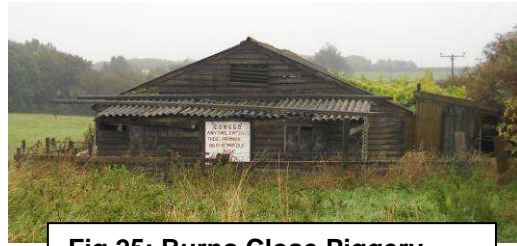
Former piggery, timber clad building with asbestos sheet roof and

Fig 24: Burns Close Piggery, Structure A/15, side view

Fig 25: Burns Close Piggery, Structure A/15, end view

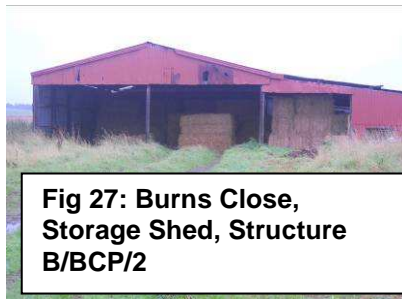
Square building with a pitched roof of asbestos sheet. Currently used as a Hayshed.

Fig 27: Burns Close, Storage Shed, Structure B/BCP/2

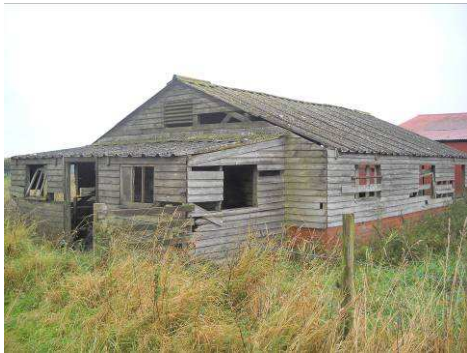
Former piggery, wooden framed with horizontal boarded walls on a base of low

bricks. Internally the remains of the pigsties are evident in the form of timber stalls with access through timber half door. Single storey lean to building at one end likely to be used for the storage of feed.

**Fig 28 Burns Close, Piggery,
Structure B/BCP/2A – 2AA**

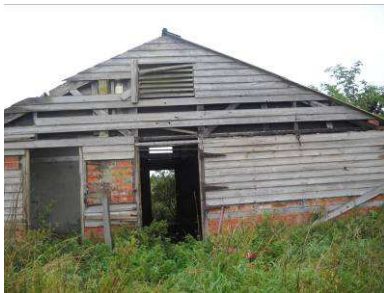
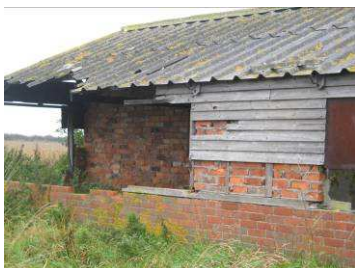
Former piggery now derelict and heavily altered to form byre and dairy for village milkman, W. Robinson (D Wall pers comm). Rectangular in plan with a pitched roof. The building is separated into two rooms by a brick wall. The interior is plastered with evidence of cattle pens. It is brick built with horizontal boarded timber walls.

Corrugated asbestos sheeting is used for the roof. Two doors give access off the lane to the property and there is a single door to the rear.

**Fig 29: Burns Close, Piggery,
Structure B/BCP/3**

**Fig 30: Burns Close, Piggery,
Structure B/BCP/3**

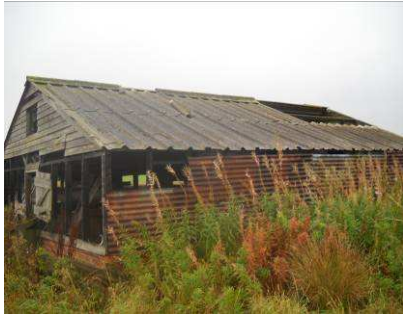
Former piggery with a pitched roof of asbestos sheeting. Base of wall is in brick with upper part of horizontal timber cladding, some of which has been lost and replaced

with corrugated metal sheets. There is a lean to at one end and evidence of pens internally.

Fig 31: Burns Close, Piggery, Structure B/BCP/4

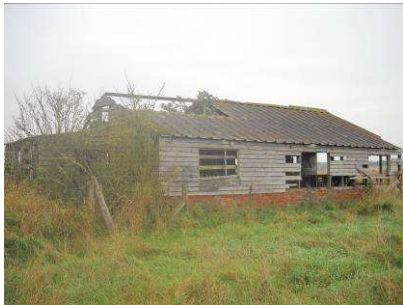
Former piggyery, wood framed with wooden, horizontal boarded walls. There is a lean to at one end, giving access to the piggyery.

Fig 32: Burns Close, Piggery, Structure B/BCP/5

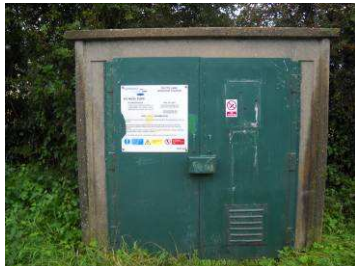
Water Pressure Booster Station, reinforced concrete structure with metal door. Built to provide water pressure to Burns Close.

Fig 33: Burns Close, Water Pressure Booster Station, Structure B/X1

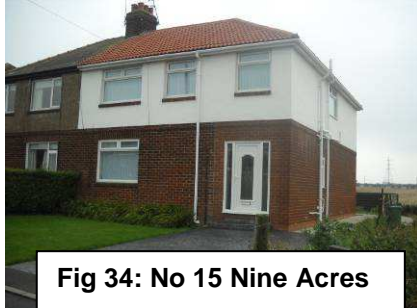
Fig 34: No 15 Nine Acres

Two storey semi-detached house, (paired with No16) square in plan with hipped roof with concrete tiles. Built in brick with rendered first floor. It shares a chimney stack with No 16 and has three pots.

replaced. There is a substantial extension to the side with first floor windows and a front entrance.

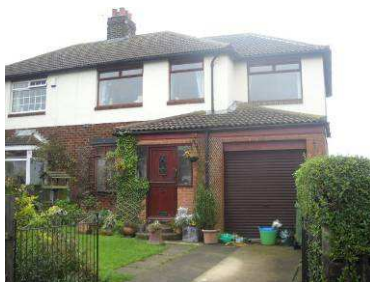
Fig 36: No 17 Nine Acres

Two storey semi-detached houses (paired with No18), square in plan with hipped concrete tile roof over. Brick chimney stack shared with No 18, three pots either side. An extension, garage and front porch has been built added.

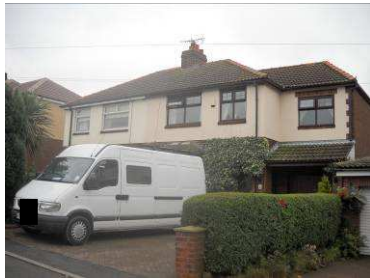
Fig 38: No 19 Nine Acres

Two storey semi-detached houses (paired with No20) square in plan with a hipped roof. It shares a chimney stack with No 20. A garage extension has been built to the side and bay window inserted to the front.

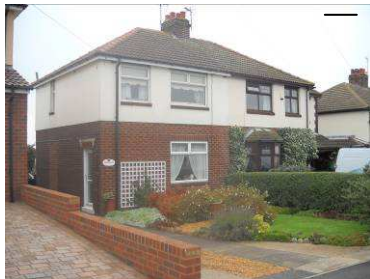
Fig 39: No 20 Nine Acres

Two storey semi-detached houses (paired with No19) and brick built with rendered and painted first floor. Original window openings retained but with replacement windows. One of the two original side doors remains but with concrete hood removed, the other is blocked up and hood removed.

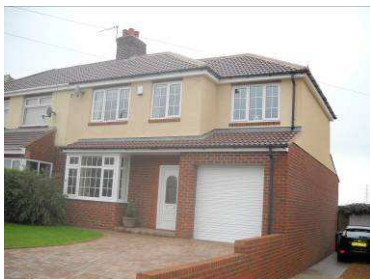
Fig 40: No 21 Nine Acres

Two storey semi-detached house (paired with No22). Built of brick with rendered first floor. It shares a chimney stack with No 22 and has three chimney pots. It has been extensively added to with garage and first floor extension to the side, brick bay to the front and with a front entrance.

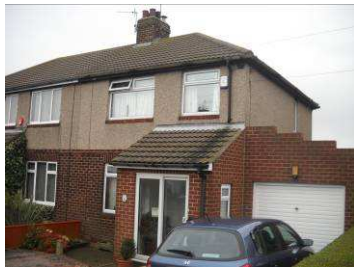
Fig 43: No 24 Nine Acres

Two storey semi-detached houses (paired with No23) built in 1937-38. Square in plan with hipped roof. Brick built with rendered first floor. Garage extension to the side and front entrance porch added.

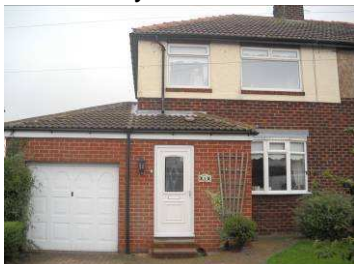
Fig 44: No 25 Nine Acres

Two storey semi-detached houses (paired with No26) built in 1937-38. Brick built with first floor rendered and painted from below windows. Square in plan with hipped roof over. Ground floor bay window and wrap around single storey porch and garage extension.

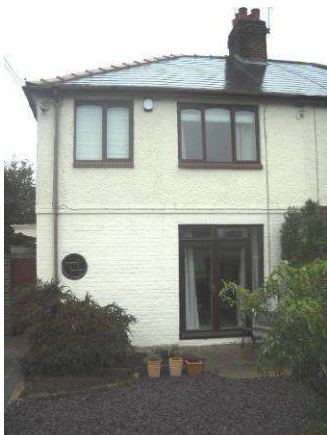
Fig 50: No 29 The Fens

This is a two storey semi-detached dwelling house; it is brick built with a rendered first floor and has a hipped roof of slates. A French window has been inserted in the centre of the front elevation. The first floor has the typical two openings, one double light and the other a triple light. The side elevation has a single doorway towards front with a concrete hood over. The ground and first floors are separated by a string course two bricks deep and projecting slightly.

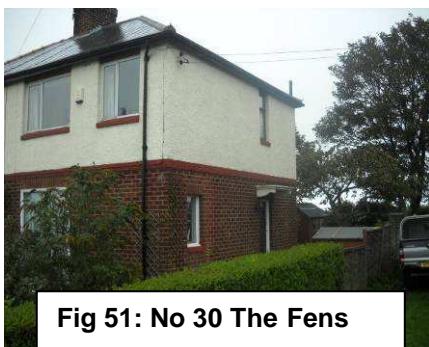
Fig 51: No 30 The Fens

This building adjoins 29 The Fens and is of the same construction. This building has also had a French window inserted into the ground floor. The side elevation has a doorway towards the rear with original concrete hood over. A doorway to the front of the side elevation has been blocked up and a window inserted. Each pair of buildings shares a chimney stack, usually with three chimney pots to each side.

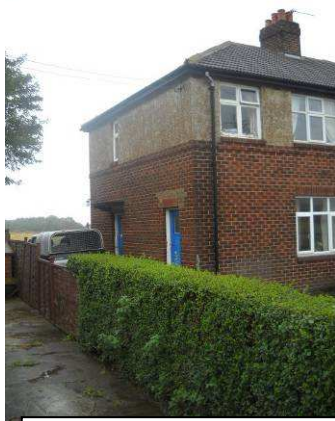
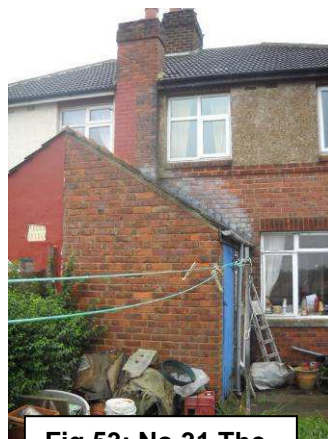
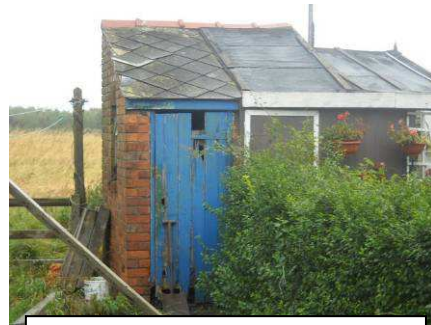
Two storey semi-detached dwelling house, brick built with rendering from mid first floor string course. Roof is hipped with concrete tiles. The original window openings have been kept but there has been some replacement with double glazing. The side elevation has original front and back doorways with concrete hood over rear but missing and patched at front. The building has a kitchen and living room on the ground floor and a bathroom and three bedrooms on the first floor. The original wash house is attached to the rear of the building with the shared chimney stack still intact. This was originally common to all the houses. There is a brick built earth closet with wooden door, last used in the 1970's at the end of the garden.

Fig 52: No 31 The Fens, front view

Fig 53: No 31 The Fens, rear view

Fig 54: No 31 The Fens, Earth Closet

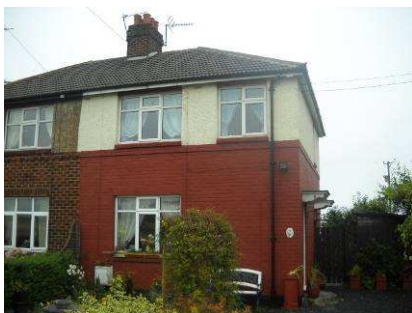
32 The Fens adjoins 31 and is built in the same way. As with 31 it retains its original

window position but double glazing has been installed. The original front and rear doorways have been retained on the side wall and both still have their original concrete hoods.

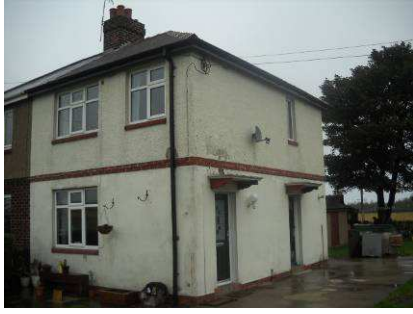
Fig 57: No 34 The Fens

Adjoins 33 the Fens and is built in the same way. The exterior is painted white. It retains its original window openings but with double glazing and has the original side doorways with their concrete hoods. This is the last of the Fens dwelling houses and there is a small orchard to the south

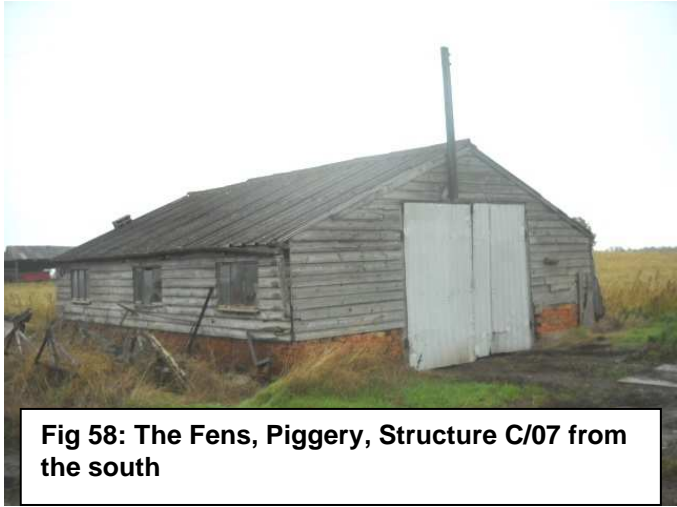
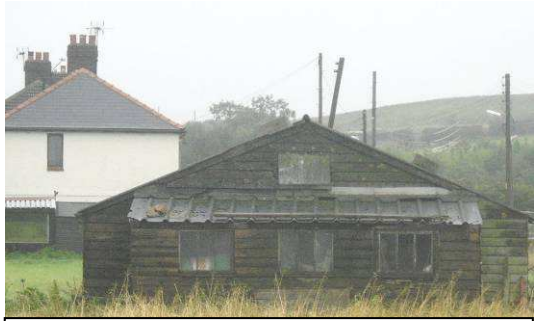
This is a former piggery, now used for general storage. It has an internal concrete

Fig 58: The Fens, Piggery, Structure C/07 from the south

The southern end of the structure is entered through double doors, covered by metal

Fig 59: The Fens, Piggery, Structure C/07 from the north

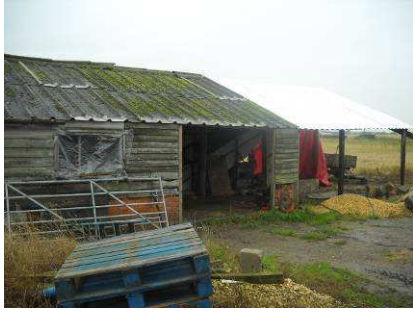
This is a former piggery now used for general storage. It is constructed in the same way as C/07 above, however the northern third of the building has been substantially

altered to allow the extension of the building to house a corn drier. The extension has a roof of metal siding

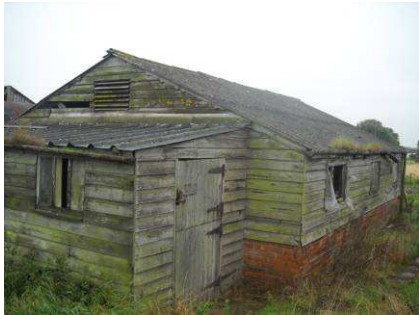
Former piggery now used for storage, description is the same as C/07 above.

Fig 61: The Fens, Piggery, Structure C/09

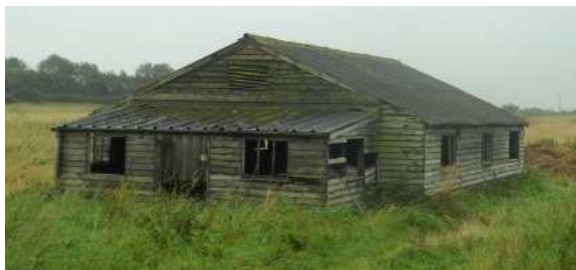
Structure C/11

Former piggery now used for storage. It is constructed in the same way as C/07; however the south end is accessed by a single door, while the north end is accessed by single stable

door through north wall of lean to. There are three windows in the west wall and two in the east; the north wall has a louvred ventilation grill. There is a 'lean to' at the north end of the building and this has a stable door in north wall, two windows in the north wall and one window in the east wall.

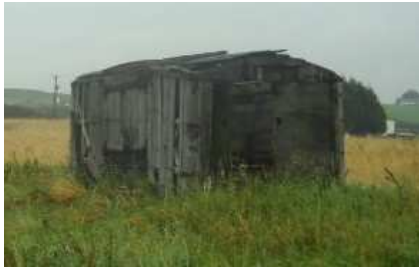
There is a derelict railway van adjacent to the piggery

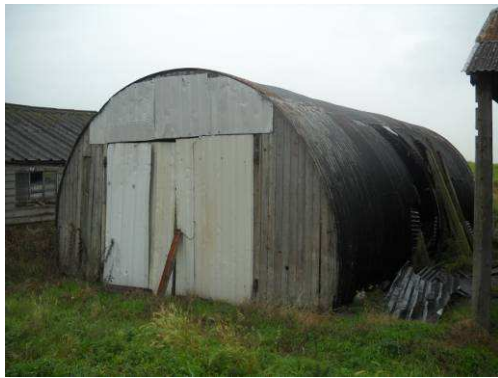
Fig 65: The Fens, Nissan Hut, Structure C/12

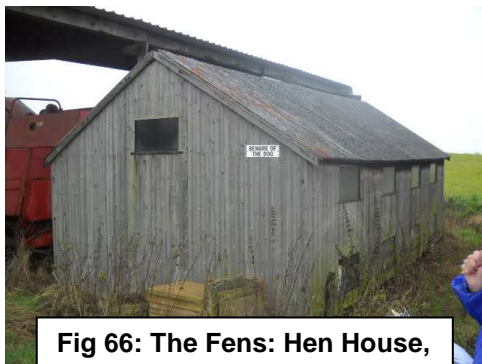
Fig 66: The Fens: Hen House, Structure C/13

has four windows at ground level and four above at c1.5m and small hen hatch at ground floor between the last two windows at the north end. The windows contain obscured glass and slide internally.

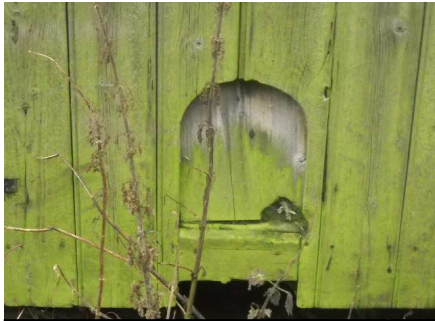
Fig 67: The Fens, Hen Hatch, Structure, C/13

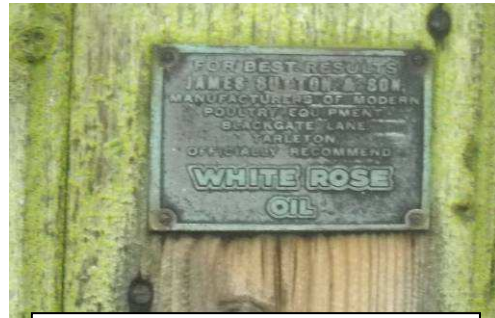
Fig 68: The Fens, Plaque, Structure C/13

The west side has four windows only all at ground level. There is a single window high in the south end. The door has a plate fixed to it and is of 'James Sutton and Sons of Darlington'.
