Archaeological Survey and Excavation

Stockton and Darlington Railway

Preston Park

TA 20/02

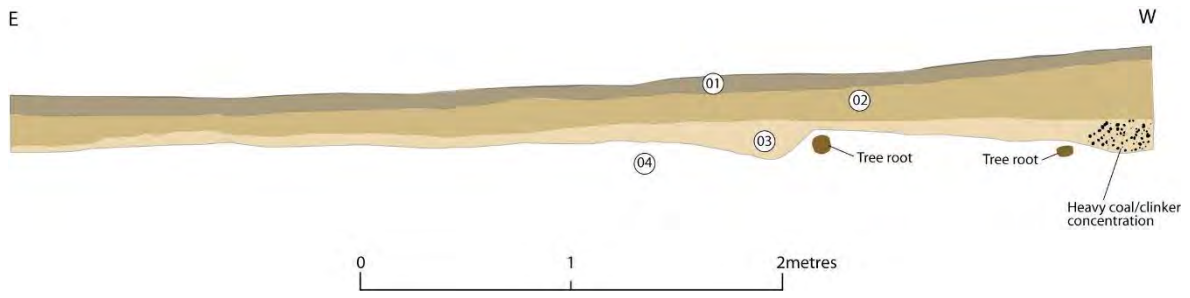
Figure 14. Section through Trench A, 2003

Key
01: Topsoil 02: Red/brown clay 03: Mid-brown soil 04: Yellow clay

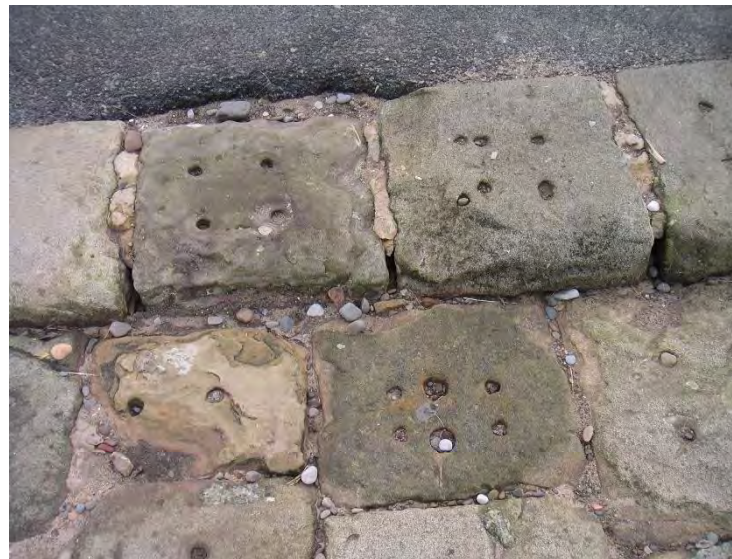
Figure 16: Granite sleeper blocks from the Stockton & Darlington Railway, re-used to construct a double-slipway at Saltburn, Redcar & Cleveland.

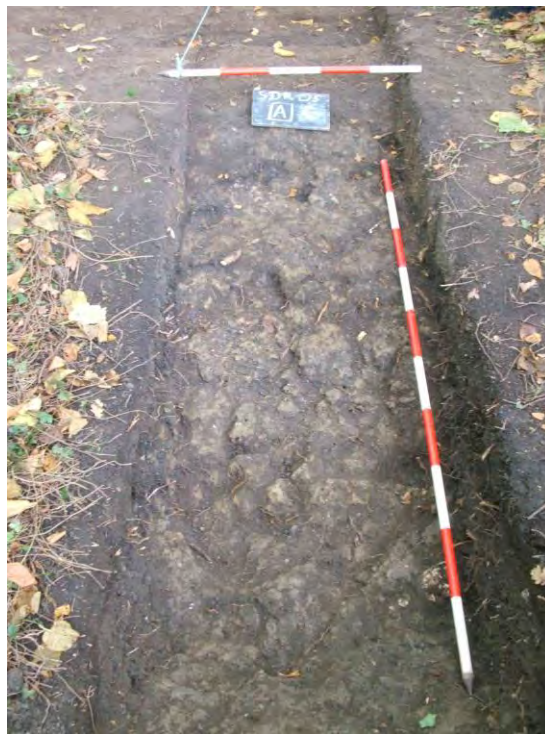
Figure 18. Poaching between the lines of the track, caused by horses moving over the ground

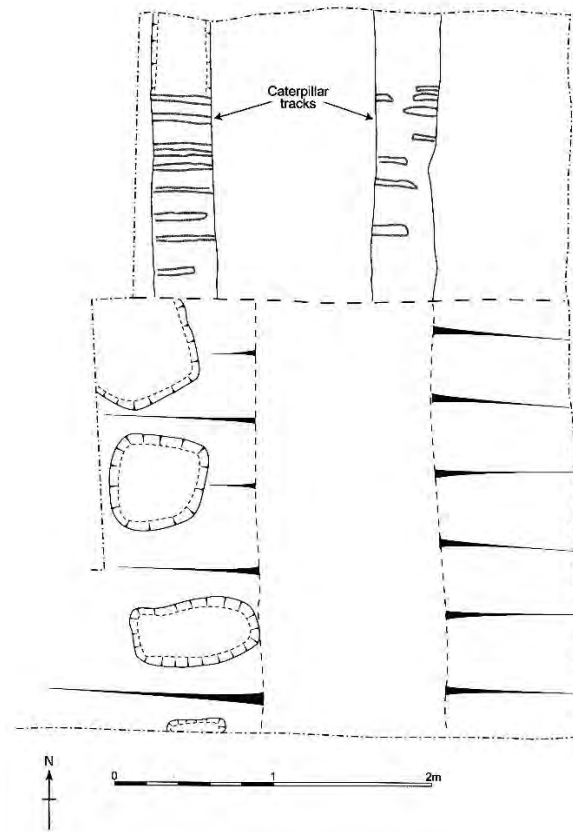
Figure 19. Plan of Trench B, 2005. The top half of the trench was only excavated on to the caterpillar tracks from landscaping, the lower half shows the block holes for the railway sleeper blocks

Following the abandonment of the line, and perhaps at the time of the acquisition of the park by the local authority in the 1950s, landscaping took place on the site. This was particularly seen in Trench B (see below). A very dirty layer of orange brown sandy clay (06) containing brick, pieces of drain pipe etc was spread across the site. This also contained a cast iron way marker (Fig. 21). This underlay the immediate topsoil (01) which had heavy tree root damage.

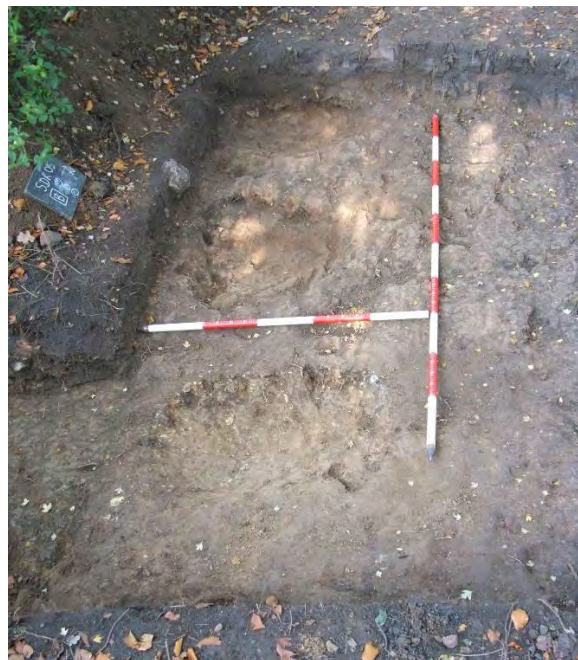
Figure 20. Trench B, 2005 showing block holes

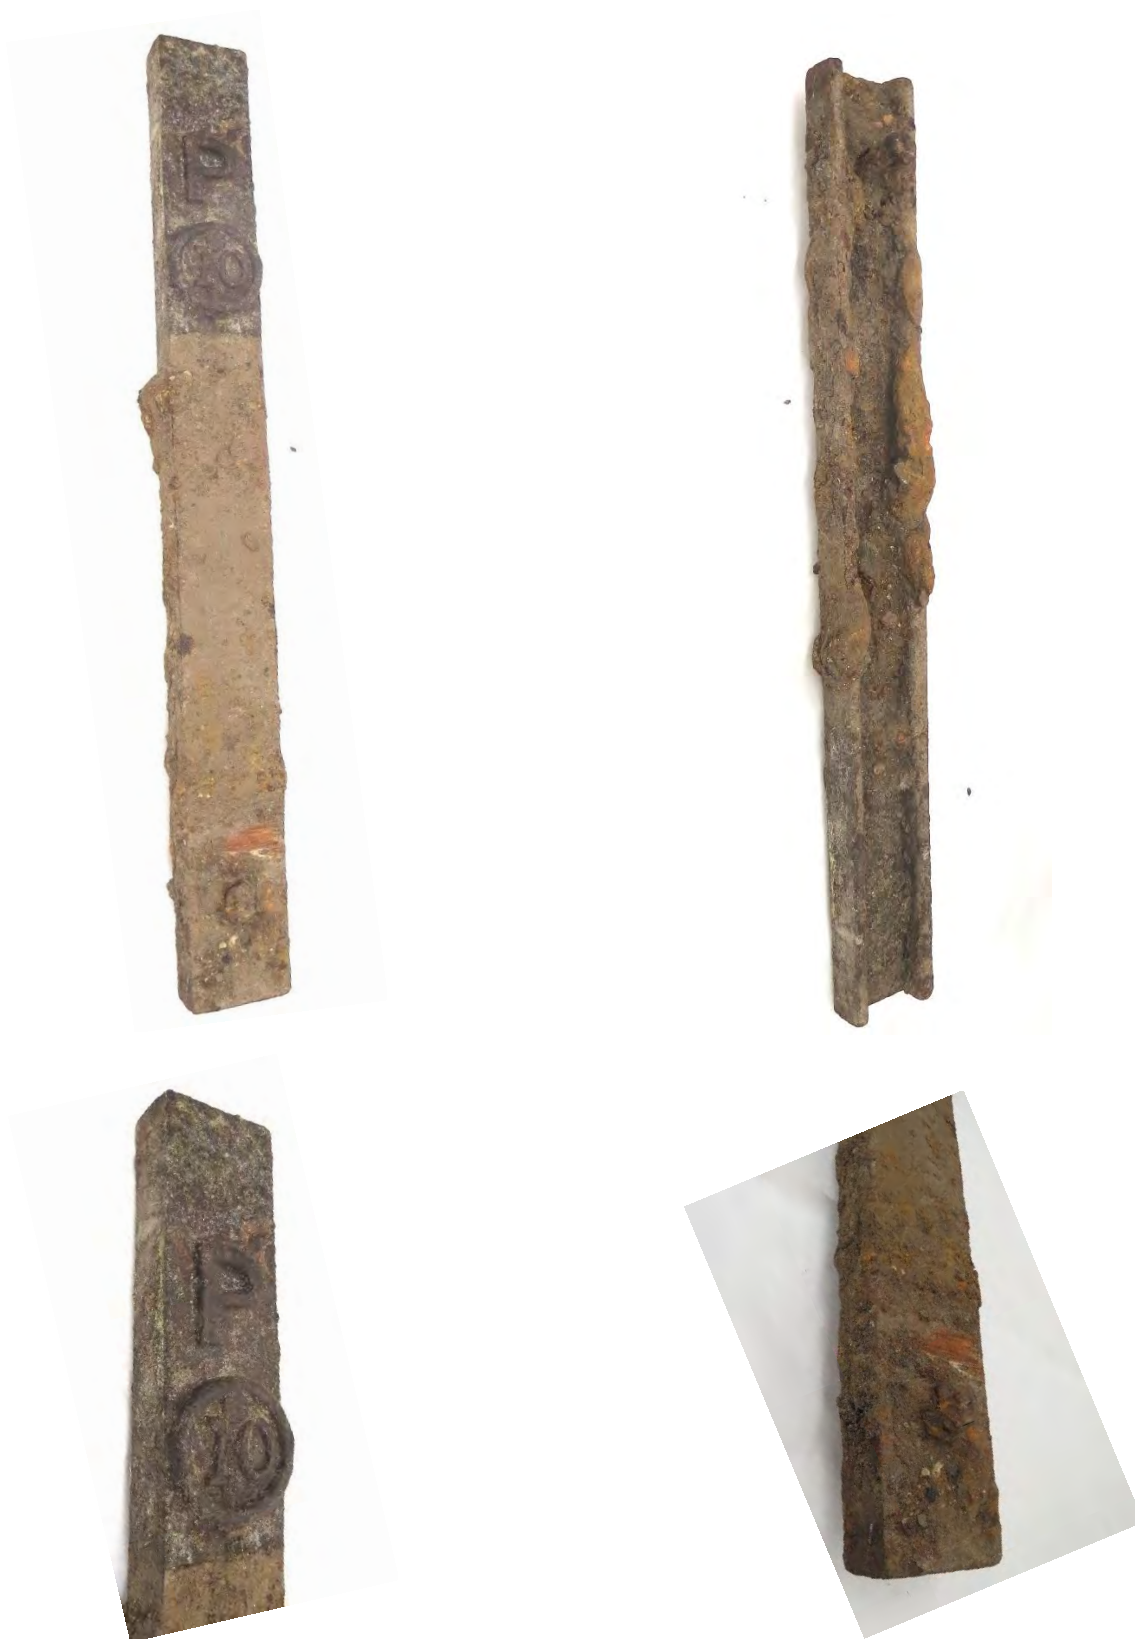
Figure 21, Marker(?) Post, front, back and detail of top and bottom of front face
