# The Heritage of Hart Project 2009

## A Historic Environment Survey of Hart, Hartlepool

**October 2009**

**TA 09/07**

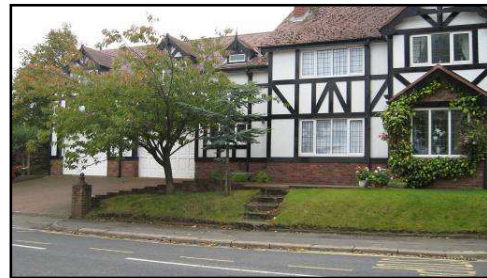
*Plate 1. – Beckwood House.*

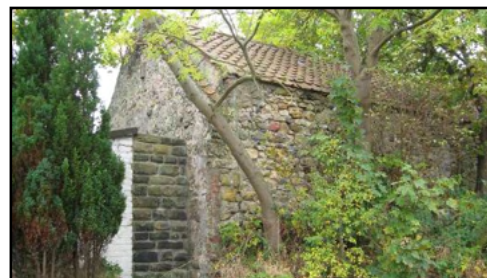
This outhouse within the grounds of Beckwood House is the only remnant of the large farm estate that used to be situated this end of Front Street. Rubble and mortar have been used for the majority of this structure, topped with modern pantile. To its north elevation is a brick extension joined by a small moulded stone wall between the two. The original roof-line from previous buildings is still visible on the stone building.

*Plate 2. – 19<sup>th</sup> century Outbuilding behind Beckwood House*

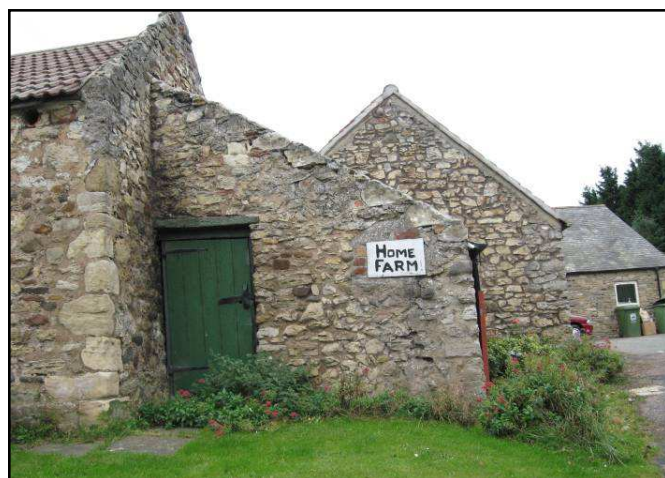
A record for each individual building has been collected for Home Farm as it is a large estate. Much of the original 19<sup>th</sup> century farm is still fully functional and in excellent condition, including a two storey stone barn building, built in the 1850s which has been converted into a residential building in recent years. This building

*Plate 3. – Home Farm. An outbuilding facing onto Front Street.*

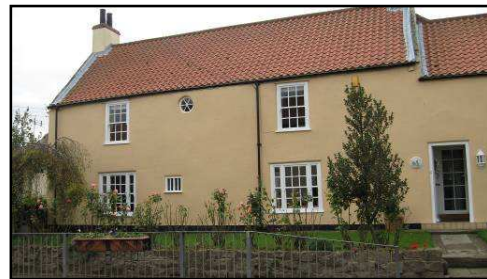
Mid-late 18<sup>th</sup> century farm house characterised by a large two storey central section with adjoining kitchen and servants extensions on either side. Previously a farm cottage to the right side with a modern garage extension. Much of the building has been modernised, with pantile and new sash

*Plate 4. – Holme Farm.*

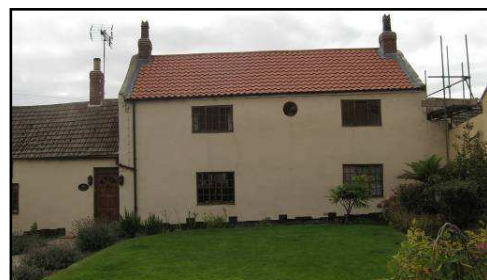
Another mid-late 18<sup>th</sup> century farm house set back several metres from the frontage. The building consists of a house and adjoining cottage. The property has a range of outbuildings to the rear which are part of Home Farm (A/03). Again, the port-hole window is incorporated, and like Holme Farm (A/04), the main entrance into the building is through the single-storey cottage.

*Plate 5. – Hart Farm.*

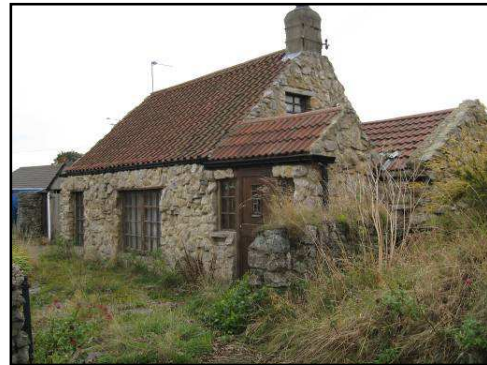
A 19<sup>th</sup> century cottage with a modern extension to its rear and two wooden garages to its eastern elevation. The visible stone and mortar facing is fairly recent, but follows the original construction. The overall structure has been heavily transformed to be used as a modern residential building. Its size indicates it probably began life as outbuildings, probably part of the farm house that used to stand where Southlands and Stone Gable is now. On the 3<sup>rd</sup> Edition Durham OS map (1916-22), it is identified as a 'Reading Room'.

*Plate 6. – White Cottage.*

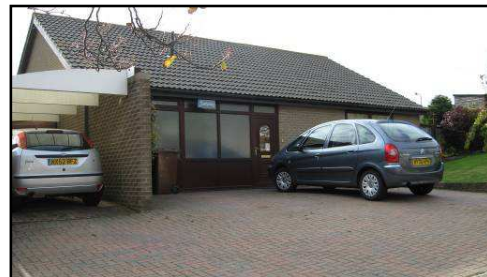
A 1980s detached bungalow with dormer to the rear, built with modern grey brick. It occupies the site of a farm house, similar to those already discussed. This fell to ruin and was demolished by the early 20<sup>th</sup> century to become small lots of farm lands to the south of the village, no doubt where the house found its name.

*Plate 7. – Southlands.*

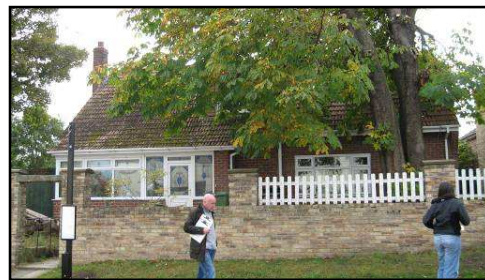
Another 1980s detached bungalow with a dormer to the rear now occupying a formerly wooded area of land between Red Sills (A/09) and Raby Arms (A/11). It is built of brick and mortar and has been positioned between some of the original trees.

*Plate 10. – Wyndways*

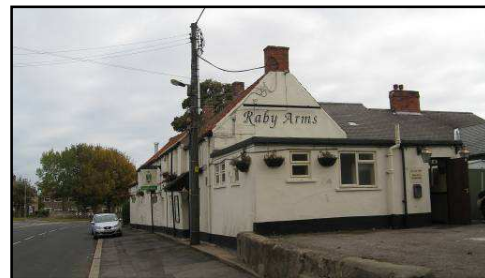
An early 18<sup>th</sup> century farm house in a similar layout to Holme Farm (A/04) which became a well known public house in the late 19<sup>th</sup> century. The original parts of the property are stone and mortar rendered white, whereas numerous stone, and more recent brick extensions, have been constructed to accommodate customers to the pub. It is possible to see the old main entrance and workshop entrance into the building facing Front Street, which has since been filled and rendered smooth. The north elevation consists of six separate buildings of differing date, clearly demonstrating the repeated need to expand the property during its use as a farmhouse.

*Plate 11. – Raby Arms*

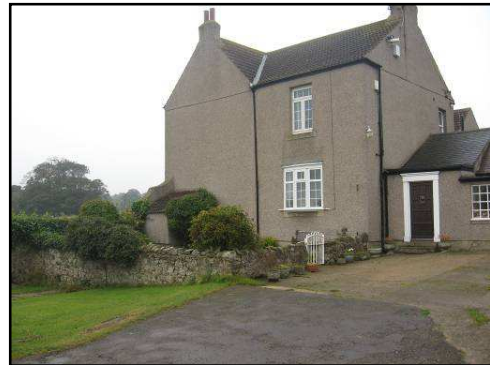
North Hart Farm Estate is a large complex of buildings, so particular attention has been paid to the key structures within the property, including North Hart Cottage, North Hart Farm, its large attached extension, and a recently built brick garage attached to the extension. It has a large collection of outbuildings, some of which date to the late 19<sup>th</sup> century, but which have since been consolidated into one large modern barn complex built by the current owners. To the north, covering a large area within the farm yard, is a small caravan park rented out by North Hart Farm.

*Plate 12. – North Hart Farm*

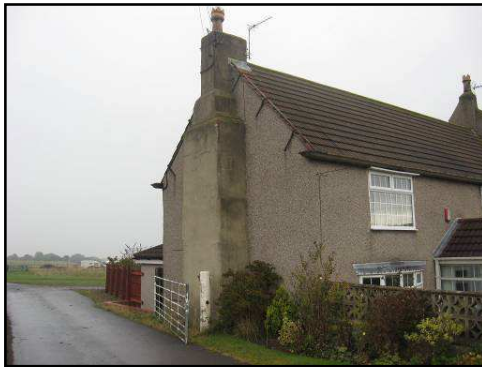
*Plate 13. – North Hart Cottage, beside Butts Lane access into farm estate.*

The cottage (A/12) and farm house (A/13) buildings have been situated here since the 18<sup>th</sup> century, although much of the current property was modified and constructed in the 19<sup>th</sup> century. The large stone and mortar extension (A/14) attached to the north of North Hart Farm was originally used to house livestock, but like so many working farms today, it has been adapted to the current needs of the farmer and converted into workshops. Recently a red brick garage (A/15) has been installed into the extension to provide shelter for modern vehicles. It is noted nonetheless, that the farm is still a fully functioning estate, even if on a smaller scale than in previous generations.

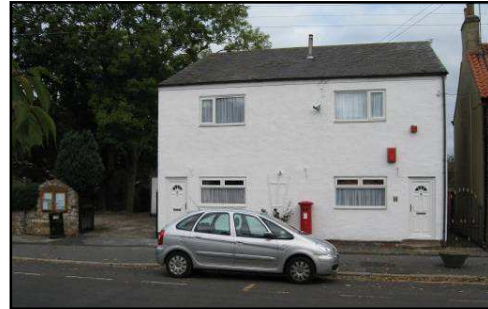
The large white property directly to the east of Butts Lane is the Old Post Office, easily identified by the red post box still outside. It has recently been converted into two semi-detached residential properties. Much of building dates back to the 19<sup>th</sup> Century where it was part of a small complex of structures. The earliest Post Office was situated on the opposite side of Butts Land, where the Village Hall (B/29) is now, although that structure has long since been demolished; it then moved to one of the end buildings on Palace Row, before ending up at 1 Front Street up until the village lost its Post Office altogether.

*Plate 14. – 1 Front Street, also locally known as the Old Post Office*

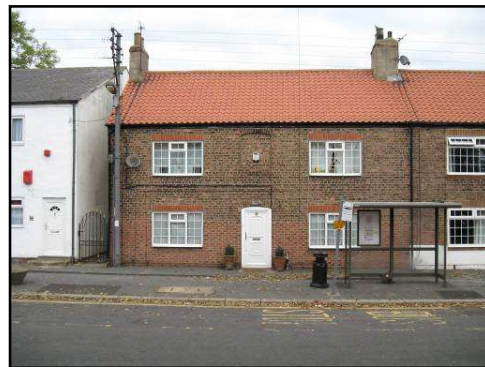
Effectively only two buildings, the eastern property has since been divided into two smaller properties, No's 3 & 4. This large building's construction date stretches into the mid-19<sup>th</sup> century and has seen relatively little modification to its general shape, although its brick work has been re-faced on the ground floor, and the roof has been modified. On both buildings an inset brick space is visible above both doors, however, the brick looks contemporary with the rest of the building indicating they were probably never used as lights.

*Plate 15. – 2 Front Street*

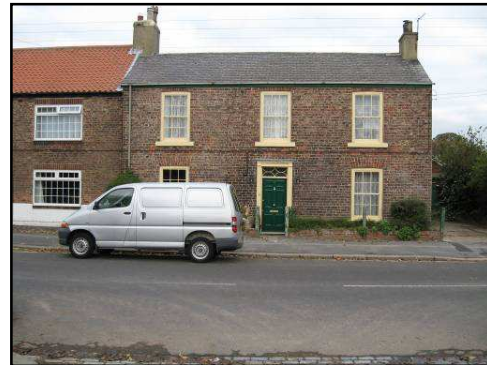
This building is Grade II Listed. Although possibly earlier, it contains many similar features to No.2-4 Front Street, including its size, proportions of features and position of door. The cambered brick voussoirs above the windows, protruding stone sills and ornate door frame are original, and, again support an earlier date for this house to that next door. The brick also looks older and the roof has retained a Welsh slate finish.

*Plate 16. – 5 Front Street*

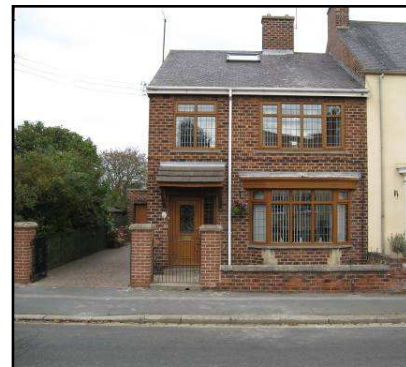
A mid-20<sup>th</sup> century semi-detached residential brick house attached to the end of a long-standing row of terrace houses. It has been constructed using similar bricks, probably reclaimed, and a Welsh slate roof to give it a more traditional finish. A detached garage can be found to the north west of the property on the site of an original outbuilding, although probably no longer retaining any of the original structure itself.

*Plate 17. – 6 Front Street*

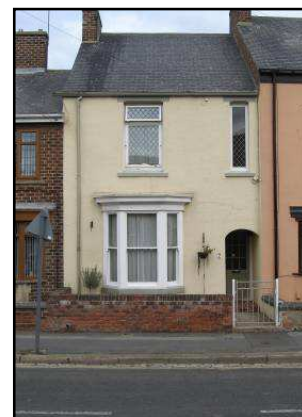
A thin terrace building, part of a building phase that occurred during the mid to late 19<sup>th</sup> Century on the north side of Front Street. The entrance was traditionally down a passage that ran from Front Street to White Hart Court until it was recently blocked off to extend the property. It is built of brick and mortar, then covered in white render, and like No. 6 Front Street (B/05), roofed in slate.

*Plate 18. – 7 Front Street*

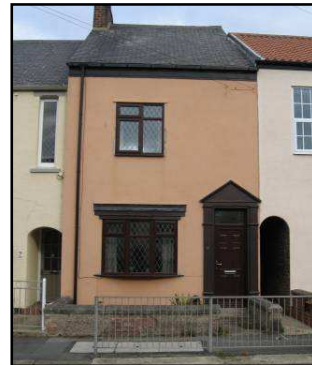
Similar late 19<sup>th</sup> Century terrace building to No.7, although modified with new wooden window frames, wooden doorcase, and rendered. It is still possible to see remnants of the original building; a small front yard wall contains very early red brick, similar to those used in the property itself, and by the front door is an original wrought iron milk bottle holder cut into the exterior wall.

*Plate 19. – 8 Front Street*

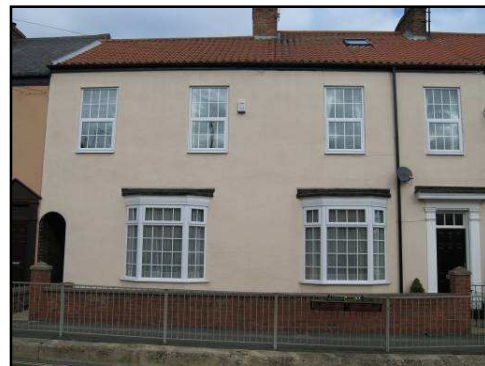
No.9 and No.10 are part of the same structure, and, according to map regression were once split into three separate buildings. Two of the properties were probably combined during the last fifty years. A side passage runs from Front Street to White Hart Court along its west elevation. The distinctive white ground floor bay windows, and the door façade are not original, but may imitate older features that once

*Plate 20. – 9 Front Street*

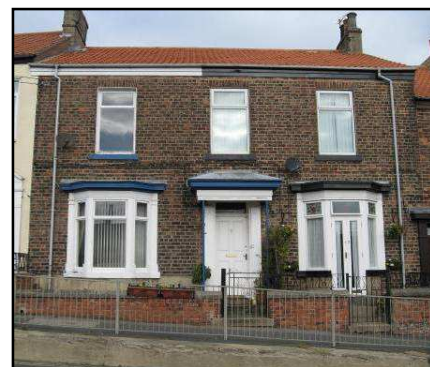
This structure contains two properties. The middle ground floor entrance is used for No.11, but the first floor room directly above this door belongs to No.12, and entrance into No.12 is through a modern inserted door cut into the right side bay window. This arrangement was apparently adopted shortly after the structure was built in the late 19<sup>th</sup> century. Cambered brick voussoirs frame the first floor windows and the painted stone bay-windows are also likely to be original, however the door canopy and façade are a later addition.

*Plate 21. – 11 & 12 Front Street*

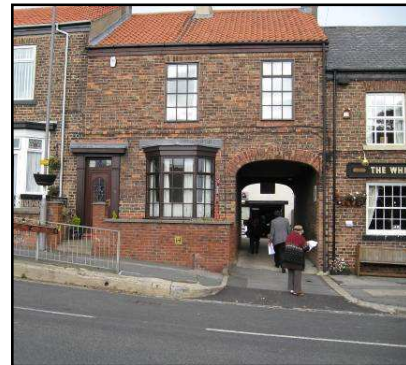
A residence easily identified as containing the main entrance into White Hart Court; a large brick arch shapes the front face of this passage which has been partly built into The White Hart, although these two buildings were built at slightly different times. Like many of the other terraces, it has a bay window and matching front entrance façade, both of which are modern imitations of original features. There is no doubt that the majority of this property has been heavily modified, as can be seen from the patches of new brick strengthening its base, and replacing removed stone sills.

*Plate 22. – 13 Front Street*

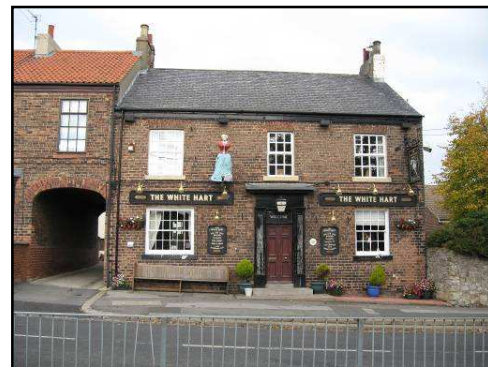
The property appears to have been purposely constructed for use as an inn, but contains many of the features present in the other residential Front Street terraced buildings including brick voussoirs on the first floor windows. A ship figure head, locally attributed to the Rising Sun of Sunderland wrecked off the coast, is bracketed to the first floor wall frontage. The roof is made of Welsh slate, in keeping with the 19<sup>th</sup> century roofing style. Unlike the front, the gable end of the building has been completely rendered white, and has been extended and squared off towards the rear which has various adjoining outbuildings.

*Plate 23. – The White Hart, public house*

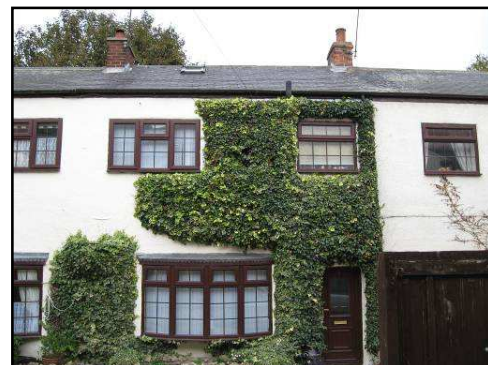
*Plate 24. – No.2 White Hart Court*

Street, including three residential properties and one workshop. 19<sup>th</sup> century in origin, they are now heavily modified with white rough render across the entirety. All windows, including the ground floor bay windows on No.1 and No.2, are recent additions. Only on the chimneys of No.1 and No.3 can original 19<sup>th</sup> century bricks still be seen, and like The White Hart, the roofs have retained their Welsh slate. Attached to No.1 is a 19<sup>th</sup> century stone and mortar outbuilding, and the workshop (B/16) has retained the winch and storage entrance on the first floor – a remnant of the past use of this property in conjunction with the pub.

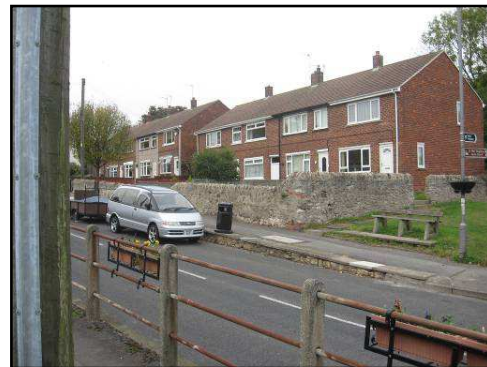
Within an early stone and mortar field boundary between The White Hart and Lindisfarne House is a group of mid-late 20<sup>th</sup> century houses called Mill View. They were built in two lots of four with modern red brick and pantile roof (although No.3 is rendered). Individually they have no real historic significance, but as a whole represent one of the earlier phases of housing expansion in Hart after the war.

*Plate 25. – 1-8 Mill View*

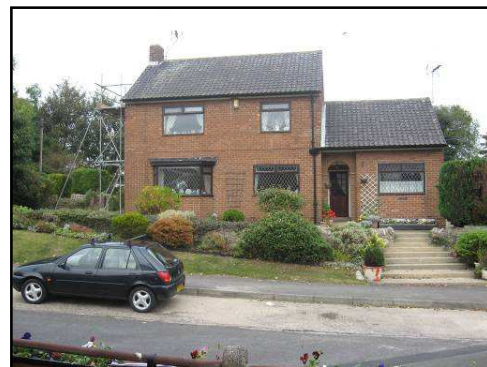
Lindisfarne House replaced the old Police Station which was built around the time of Mill View and in use up until the 90s, whereupon the police centralised to Hartlepool. It is essentially modern, but with styles touching upon traditional; with window heads styled with bricks laid header-flat and a bay window on the front. The entrance into the property is found within a porch of the single storey ‘extension’ to the side of the main two storey building, reflecting the style of the large farm houses like Holme Farm (A/04) and Hart Farm (A/05).

*Plate 26. – Lindisfarne House*

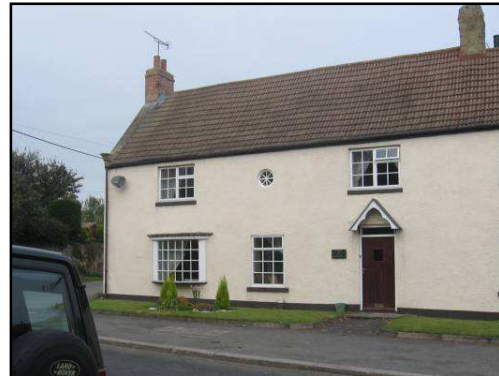
One of the original 18<sup>th</sup> century farm estates, once again, its port-hole window is a striking feature. The grounds itself were originally quite extensive, and as the name suggests, there was a brewery here. The exact date of the Brewery is unknown, but it may have provided ale for the two public houses in the village from the mid- 19<sup>th</sup> century at least. Brewery Farm is two conjoined buildings, only differentiated by a roof ridge line of differing heights. The property is completely covered in rough render which overlays rubble and mortar. The roof is modern pantile but has retained its gable copings with kneelers, although now somewhat smothered with mortar to consolidate them, as is the middle 19<sup>th</sup> century brick chimney stack.

*Plate 27. – Brewery Farm*

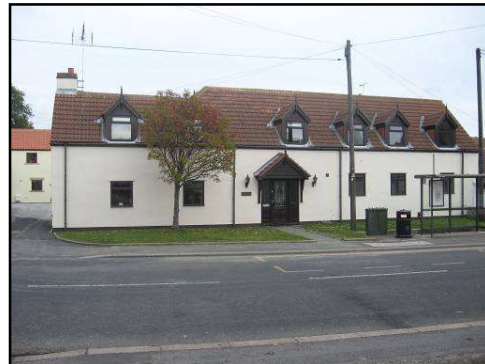
A very heavily modified collection of 19<sup>th</sup> century single storey cottages/outbuildings into one large residential property built of stone and mortar then smoothly rendered white. The roof is modern pantile and contains a very recent attic conversion which is visible via six stylised wooden dormers with a finial on each. The main entrance to the property is central to the converted residential building and has been presented with a peaked wooden canopy, imitating the dormers above.

*Plate 28. – Brewery Cottage*

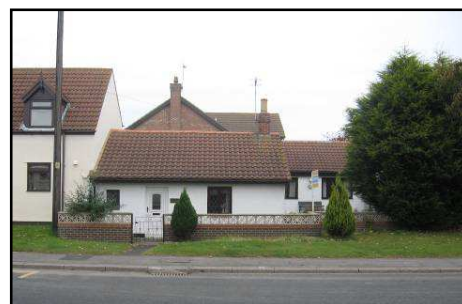
A single storey 19<sup>th</sup> century cottage with a spread of attached outbuildings including a modern 20<sup>th</sup> century brick extension of the east wing incorporating a garage. Like Brewery Cottage, Raby Cottage has seen much modification.

*Plate 29. – Raby Cottage*

Every wall face has been rough rendered in white and modern pantile has replaced its slate roof; because of this it is hard to see what has survived of the 19<sup>th</sup> century structure.

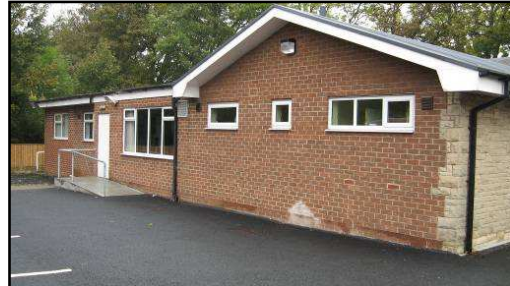
This modern Village Hall occupies the site of the former 19<sup>th</sup> century Post Office which was demolished by the turn of the century. This current community building was erected in the 1930s and subsequently heavily modified. The original English Garden Wall Bond brick work survives only as a small section of gable end on the south elevation; the rest is all recent brick in a contemporary stretcher bond. The south elevation of an extension to the west has been faced with moulded sandstone, purely for decorative reasons, and the roof has been sealed with a modern thin plastic material.

*Plate 30. – Hart Village Hall, on the corner of Front Street and Butts Lane*

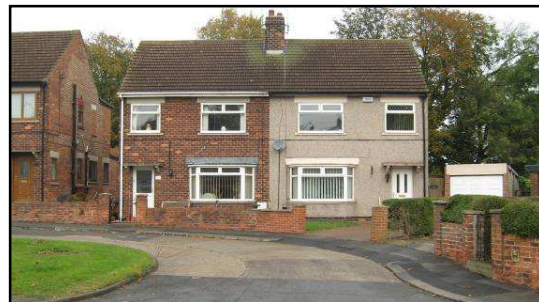
Some of the earliest 20<sup>th</sup> century housing development includes the small close of 6 units of 12 semi-detached properties just off Palace Row, called South View. Although a few of the houses have retained their brick work, others have either been rough rendered grey or, as in the case of No.11, faced in moulded sandstone very similar in format to the Village Hall (B/29).

*Plate 31. – No.3 & 4, South View.*

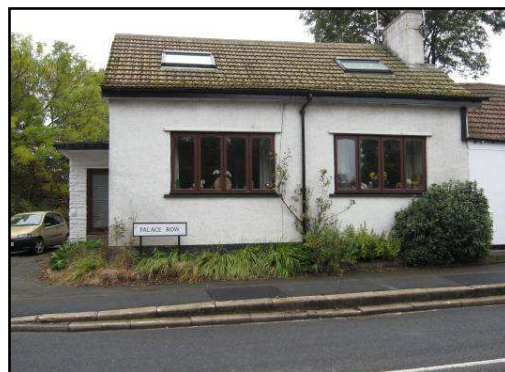
This single storey property has remained relatively unchanged since its use as the village school, before the larger primary school off Magdalene Drive was built. On a small section of surviving

*Plate 32. – Bede Cottage, Palace Row*

boundary wall (D/19) within the school grounds, the slate foundation plaque still survives (see Plate 55) with the engraving, ‘*This School Room was built by His Grace the Duke of Cleveland 1838*’. It began as a single small room of stone and mortar construction, much the same shape and size as the other Palace Row cottages, but it has since seen a series of extensions. In the late 19<sup>th</sup> century it was doubled in size with an extension to the south, and in the early 20<sup>th</sup> century a small moulded stone porch was added to the east elevation. The attic has been converted to allow for a second storey and skylights have been installed.

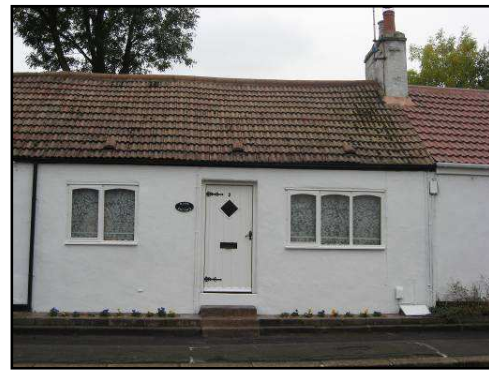
Attached to Bede Cottage is a row of six cottages, probably built at similar time to the school room itself. Each property and its boundaries (particularly the back garden boundary walls) have remained unchanged since they were constructed. The archway between No. 3 and 4 (see Plate 34) indicates a difference in construction time – indeed, the 1840 Tithe Map suggests a large gap between the last

*Plate 33. – No.2 Palace Row*

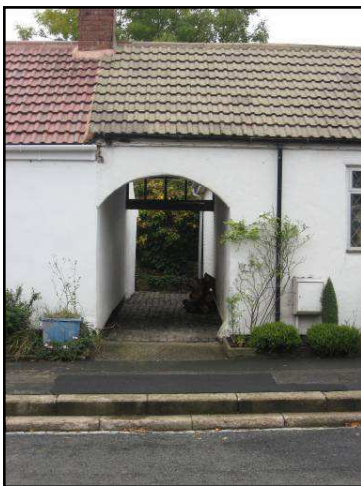
*Plate 32. – Arched passage to rear of Palace Row properties, between No.3 & 4 Palace Row.*

to the current No. 6 Each cottage has been built of stone/rubble with large amounts of mortar, and in recent years rendered white like so many of the older stone faces in the village. An example of this stone work can be seen on a visible section of No. 5 (see photo B/47/4) which is currently under restoration. It should also be noted that for a time in the late 19<sup>th</sup> century this particular property was the Post Office. Another striking feature of the entire row of cottages is how high they are above the current road level. The age of these buildings can be seen quite clearly against the heavy usage and wear of the land directly in front of them, so now a series of steps and a deep kerb separate Palace Row from the main road.

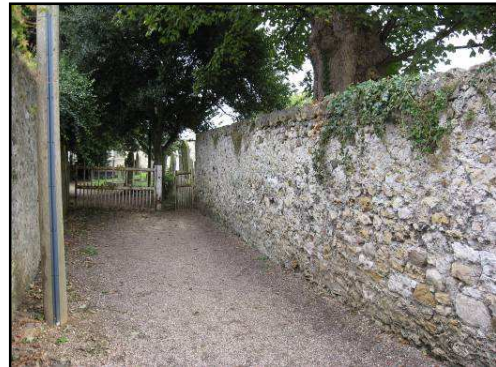
approximately 2m. The bottom half of the wall contains more moulded magnesian limestone blocks, steadily replaced by rubble towards the top, at the wall's thickest point stretching to a depth of approximately 0.35m, with a mixture of lime mortar and recent mortar/cement re-facing. It is important to note this detail now, as almost every wall in the older village core is built in a similar manner.

*Plate 35. – The Chare & wall near churchyard gate.*

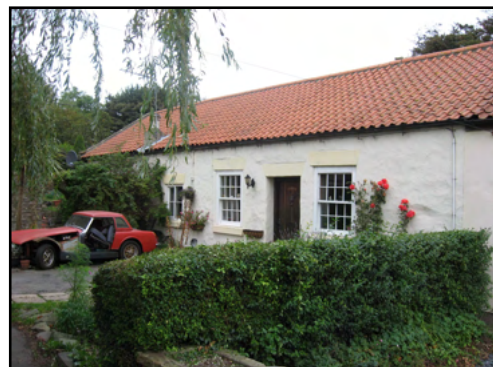
extension was made in keeping with the original features of the building including treated timber roof supports over stone rubble and mortar walls, all rendered inside and out. Features of note include the early sash windows and a Victorian stained-glass window on the north elevation.

*Plate 36. – Voltigeur Cottage.*

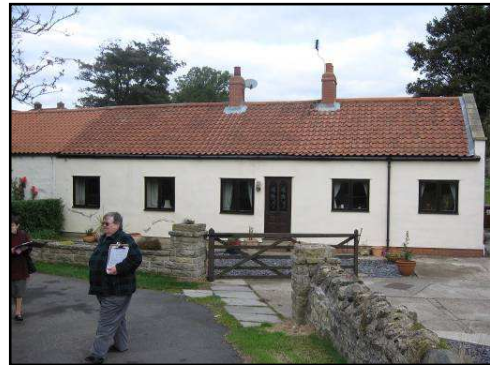
Dwelling converted and extended from 19<sup>th</sup> century stable attached to Voltigeur Cottage (D/02). The eastern end of the property from the current front door has recently been built with brick and cement, and a further extension has been added out from the north side of the property. It is unclear whether or not this was a stable itself, or just a collection of outbuildings as depicted in the 1<sup>st</sup> Edition Durham OS map (1857-61). Its back garden includes almost the entirety of the land to its north up to the churchyard boundary; this land was, until recently, village allotments.

*Plate 37. - 1 Brewery Cottage*

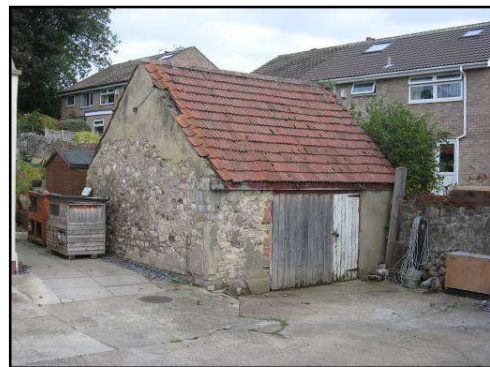
A small, square, single-storey shed approximately 1m from the current end of 1 Brewery Cottage. It is built of stone and mortar, with several areas of recent repair, including the pantile roof. A single large entrance is found on the south elevation of the structure. According to the 1<sup>st</sup> Edition Durham OS map (1857-61), the building is much smaller, indicating that the property seen today is not original, or is very heavily modified.

*Plate 38. - Storage Shed*

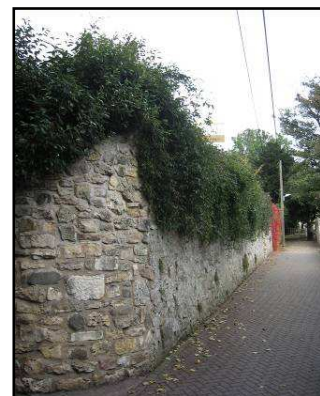
This boundary wall is similar in age to the opposite boundary wall (D/01) and originally surrounded the immediate land owned by the Manor House estate. A newer property has been built within this boundary called Chare House, with subsequent changes. The east-facing entrance has been enlarged to a double door, and a garage has been attached to the wall on the south face.

*Plate 39. - Chare House wall.*

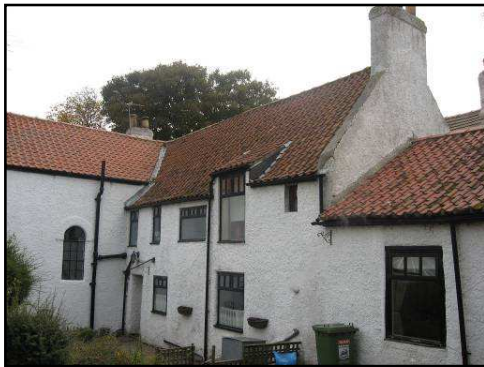
*Plate 40. – The Old Vicarage*

As the name suggests, the property was originally the Vicarage. Elements are definitely 18<sup>th</sup> century, possibly earlier. A composite of gables, varying in size, and further extensions on several faces of the 'L' shaped property, aptly express its age. The narrow rectangular shape of the middle portion of the Old Vicarage (Plate 40) is indicative of Medieval design; whether the property has retained any Medieval features is perhaps unlikely, but foundations dating back that far may still exist. Chaplain's Well forms the north wing of the

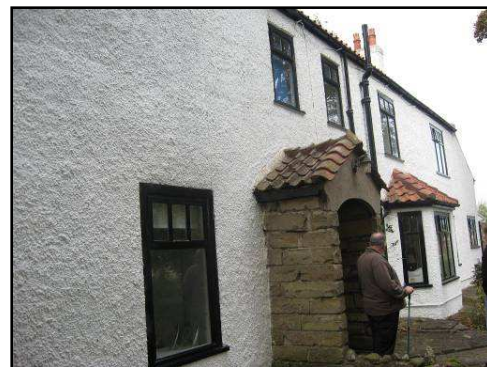
The entire structure is of stone and mortar, with the thicker walls of the Old Vicarage and its outbuildings in-filled with rubble. An interesting feature is a slate plaque adorned with the date '1847' suspended as a keystone above a now blocked and rendered arch head doorway – this may well be the foundation date of the current Chaplain's Well.

*Plate 41. – Chaplain's Well*

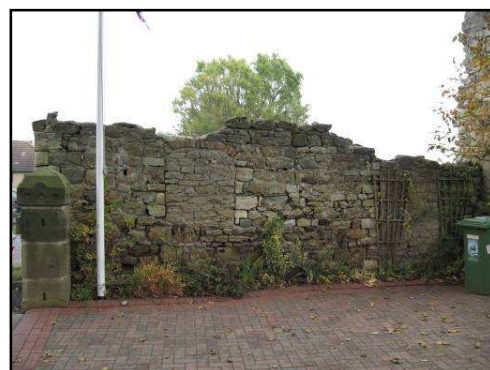
*Plate 42. – Manor House, Wall 1*

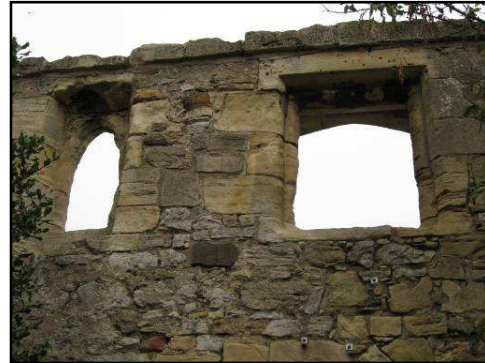
*Plate 43. – Two windows in Brus Wall*

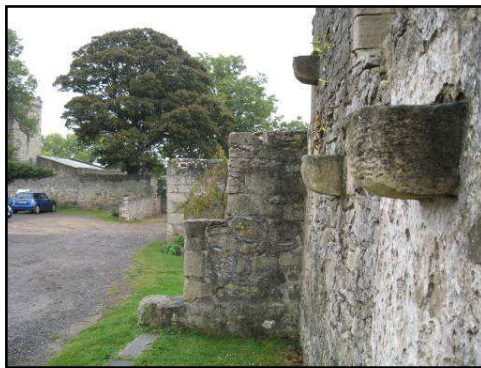
*Plate 44. – Detail of joists in Brus Wall*

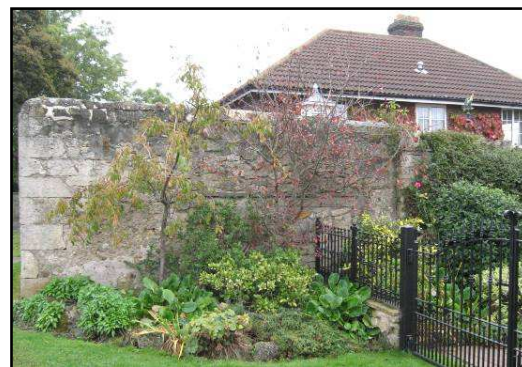
*Plate 45. – ‘Garage’ Wall 3, hidden by foliage*

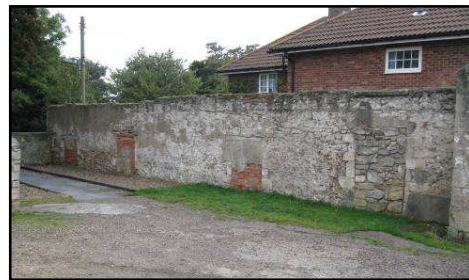
*Plate 46. – Manor House Wall 4*

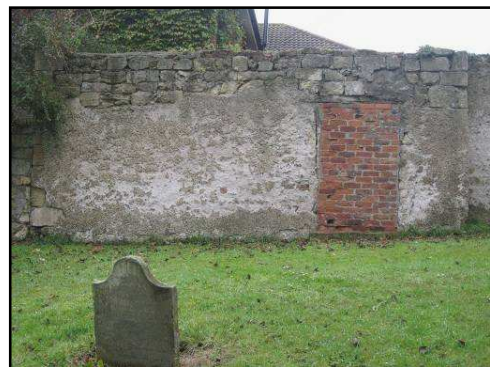
This wall comes in two sections. The corner joining the low west gate wall is almost entirely rendered in mortar. Its top has been repaired with brick in various instances, but what is visible is typical stone and mortar construction. It is contemporary with the north elevation, at least until the second section which protrudes approx 0.47m from the first. A single 2m high entrance in-filled with brick survives within this second section facing east into the churchyard.

*Plate 47. – Manor House Wall 5*

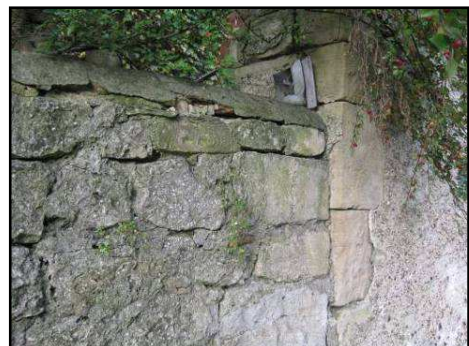
*Plate 48. – Detail of join between Wall 5 & 6*

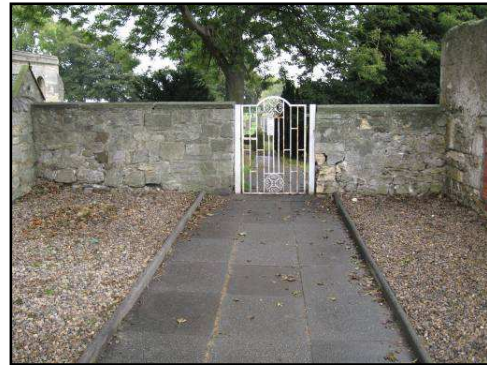
*Plate 49. – Churchyard West Gate*

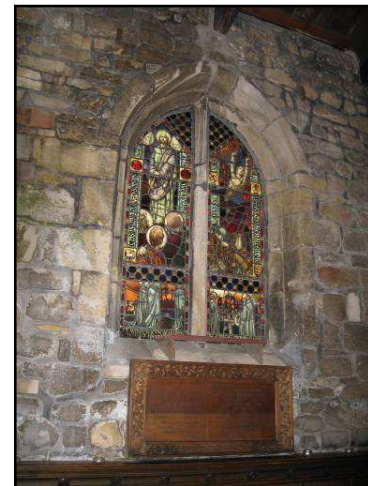
*Plate 50. – Stain glass window in South Aisle*

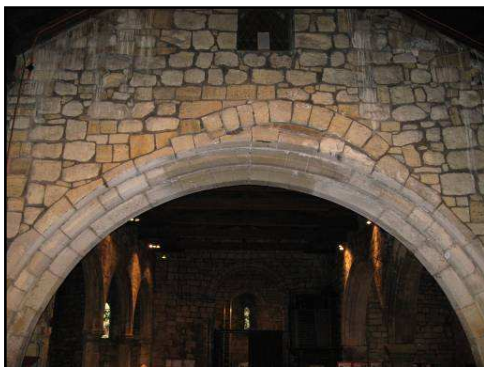
*Plate 51. – Window and earlier arch above arch between Nave and Chancel*

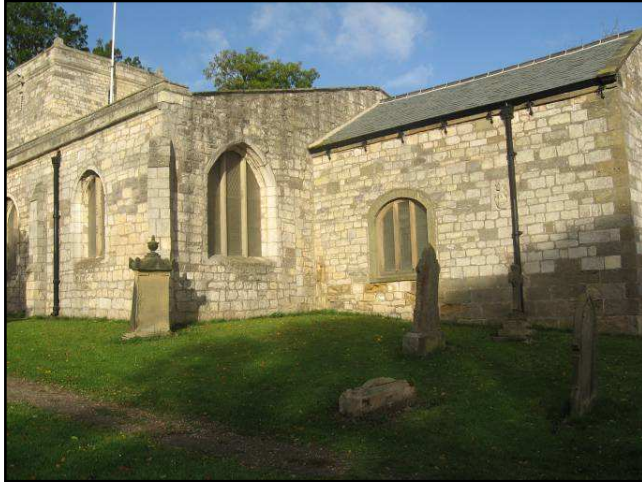
*Plate 52. – St. Mary Magdalene Church exterior, showing the corner joining the Chancel and the South Aisle.*

stone tower. The top of the Tower has a moulded stone string with protruding stone overflow features beneath a more recently constructed Tower parapet. Every face of the church appears to have windows of unique design and date, for example, the west face of the South Aisle has a pointed arch window of a separate date to the wall face itself (another example of reclaimed stonework). Its moulded sandstone arch-head still embellishes a somewhat weather-worn carved flower feature. Tucked between a moulded stone buttress on the north side of the Nave and the North Aisle, a small red brick boiler house with its own exterior entrance has been added to supply the church with heat and hot water, with a thin brick chimney rising to an ashlar stack.

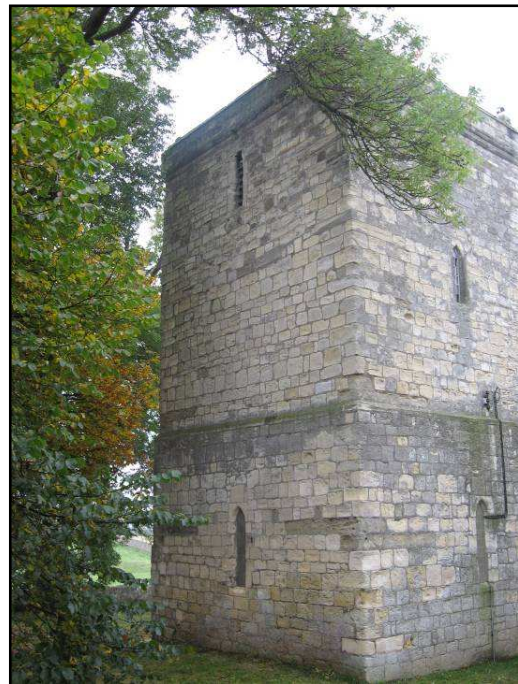
*Plate 53. – St. Mary Magdalene Church exterior, showing the south east corner of the Tower. Note the two large, darker stone slabs dressing the corners at intervals.*

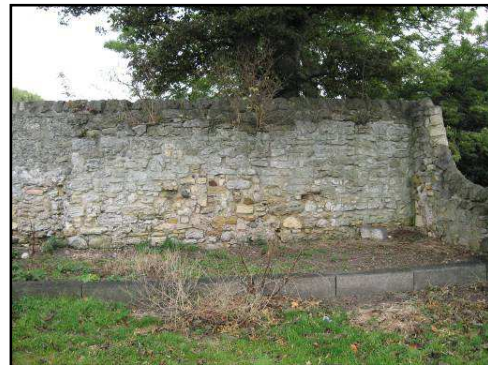
Plate 54. – Manor House Wall 8. East wall of car park/west wall of churchyard.

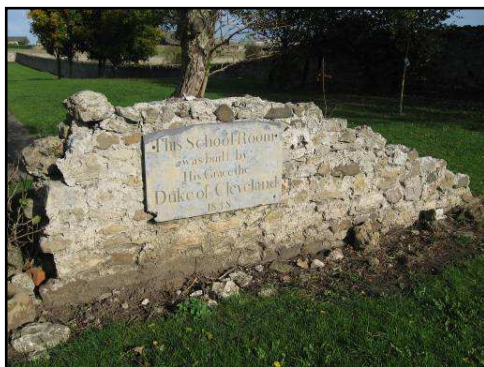
Manor House Wall 10 & 11 (D/18 & 19)

Only two sections of this wall survive, originally part of one of the Manor House field boundaries. A portion of its corner with moulded stone quoins survives as well as a reduced section within the current primary school grounds (see plate 56).

Plate 55. – Manor House Wall 11. A remnant of a Manor House field boundary.

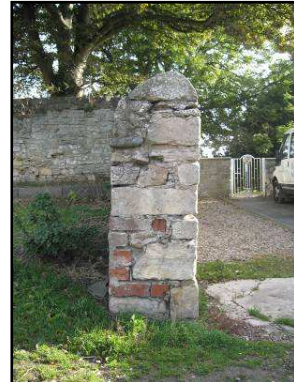
This wall joins D/16, and is also heavily reduced and modified with 19<sup>th</sup> century bricks and tile, but recently topped with mortar to provide stability.

*Plate 56. – Manor House Wall 12. A cross section through a heavily modified outbuilding wall. Note the outer face is nicely faced with magnesian limestone, but faced inside with reclaimed brick and*

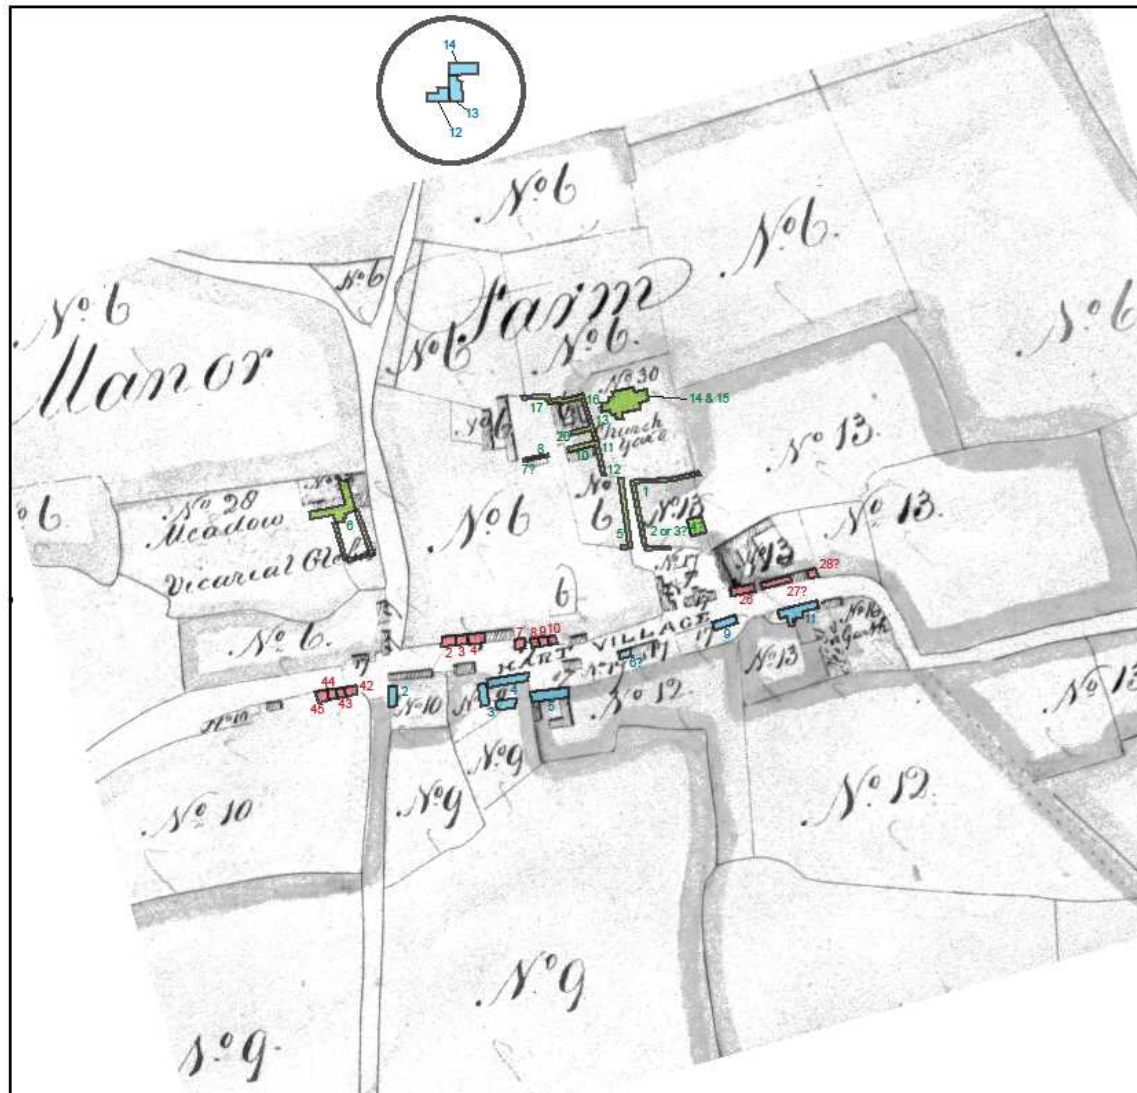
Figure 7: Extract from 1841 Tithe Map of Hart, rotated to overlay subsequent OS maps as accurately as possible
