Archaeological Excavation

Tennant Square
Stockton-On-Tees

TA22/02

September 2021

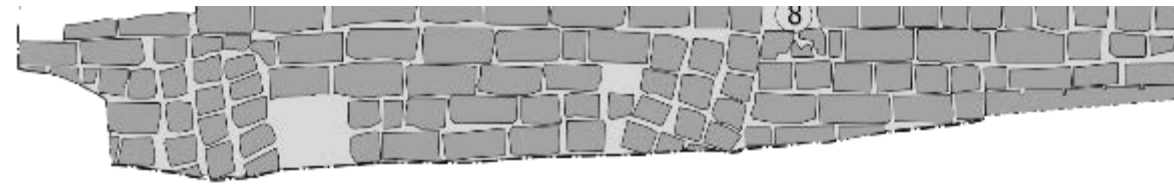
Figure 8: Sections

North wall foundation, south facing elevation, Section 1

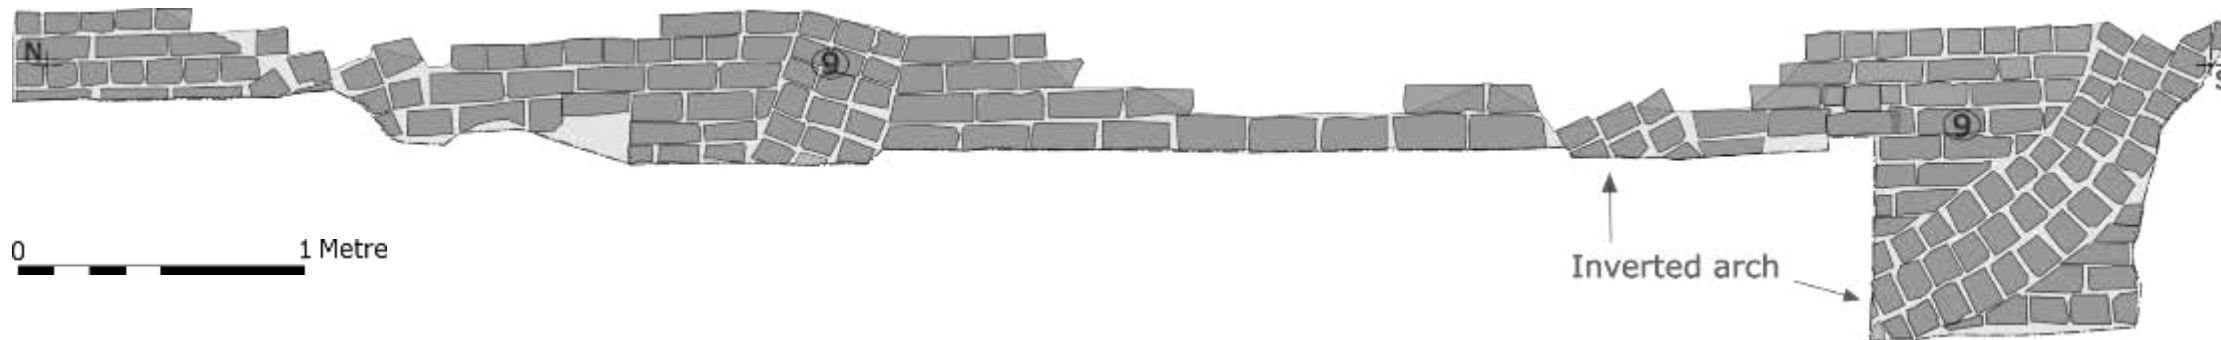
East wall foundation, west facing elevation: Section 2

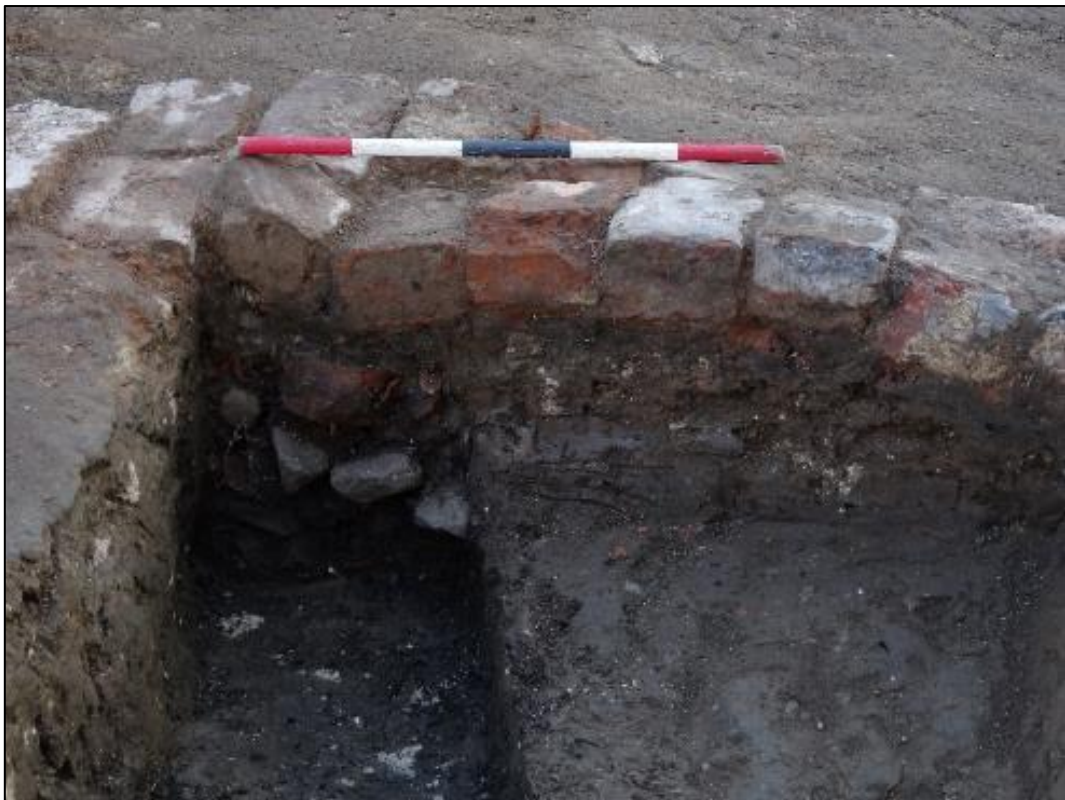
Figure 13: French drain (24), under excavation, looking SE

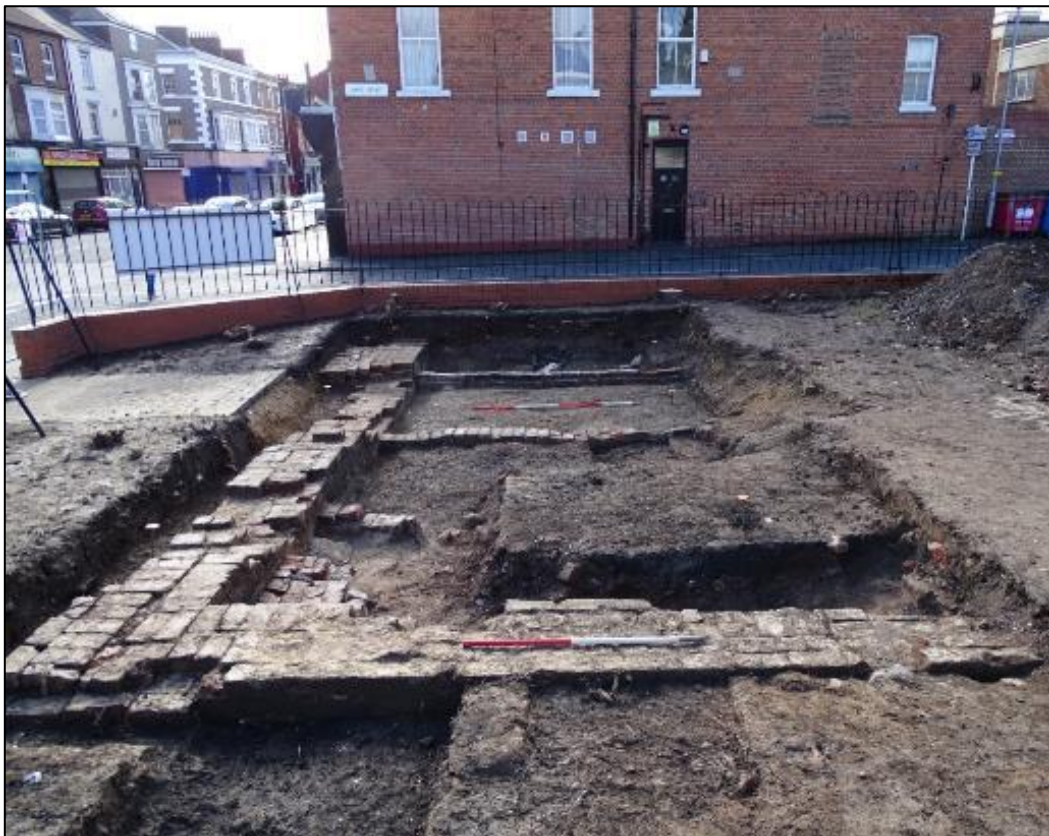
Figure 15: Overall view of the excavation area, looking north

Excavation Area (Figures 1 – 3, 15, 16 & 23)

The excavation area was orientated north-south and measured 10.5m long by 5.5m wide. It was excavated to a maximum depth of 1.2m to a point where the natural glacial clay was

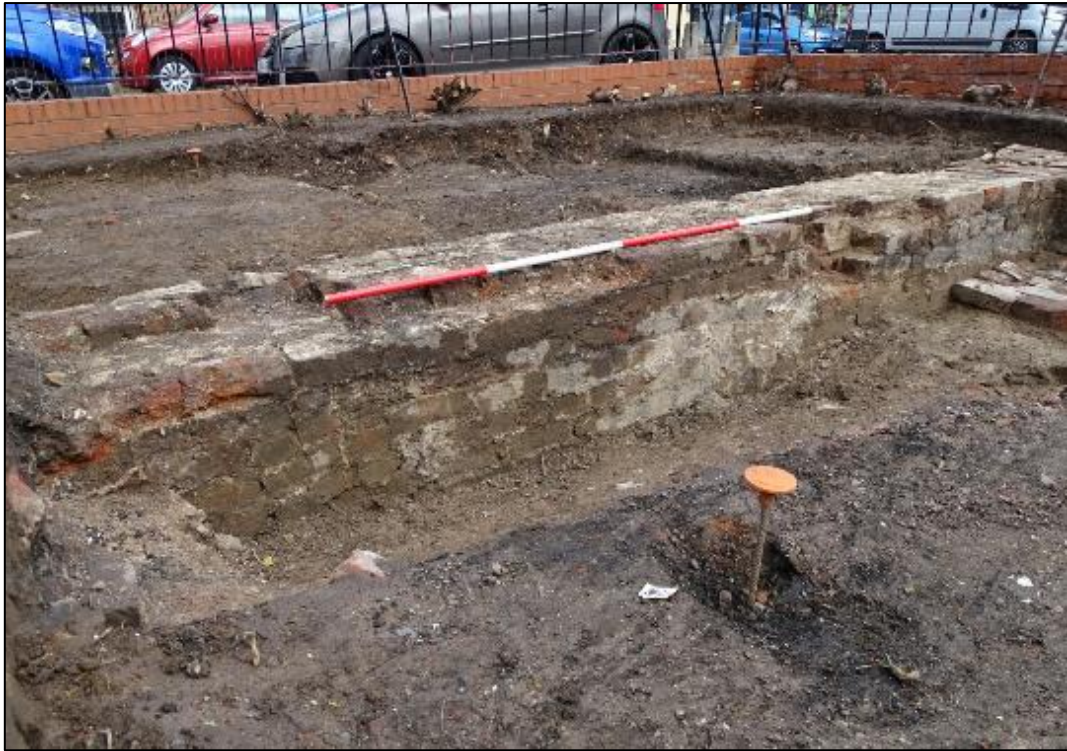
Figure 16: Overall view of the excavated area looking south

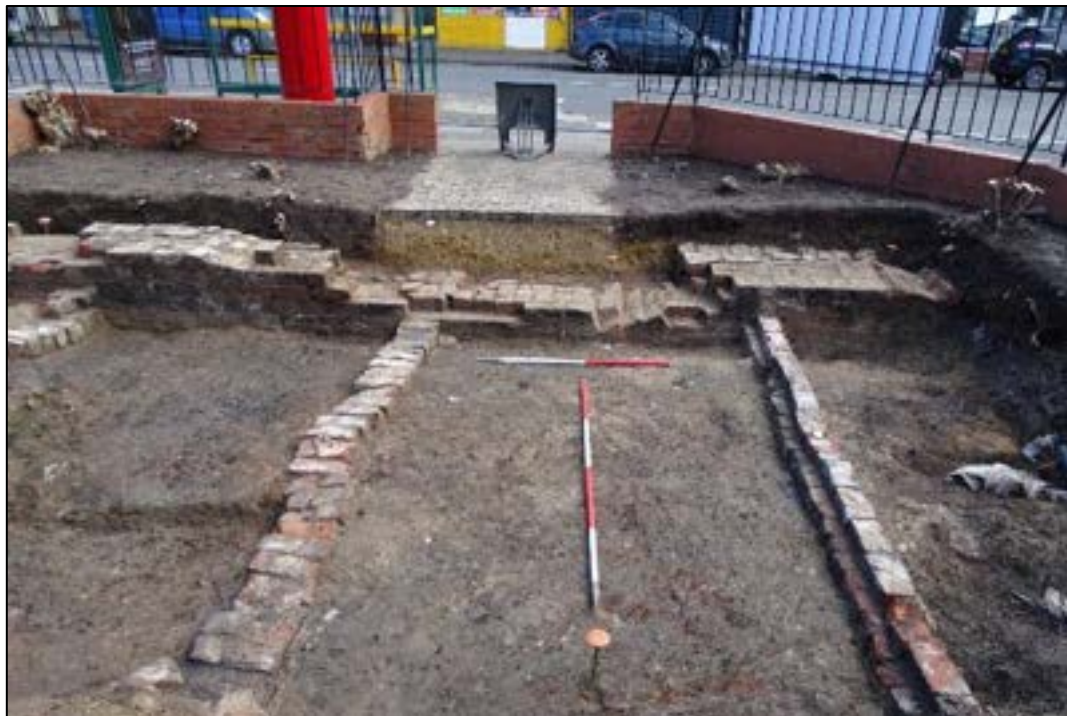
Figure 17: North wall foundation (8) south facing elevation

The north facing wall foundation of the church (8) was exposed for 4.2m in the north part of the trench. It continued below ground level to the west out of the area of excavation. No construction cut was visible for this foundation wall. The east end of the foundation was tied into the west face of the north-south wall foundation (9) forming the north-east corner of the church.

Both contemporary wall foundations (8 & 9) were constructed of red-brick bonded with cement mortar. The foundation walls measured 0.6m to 0.64m wide. The foundations were mostly constructed in stretcher bond interrupted with inverted arch footings or upside down arches laid in header bond.

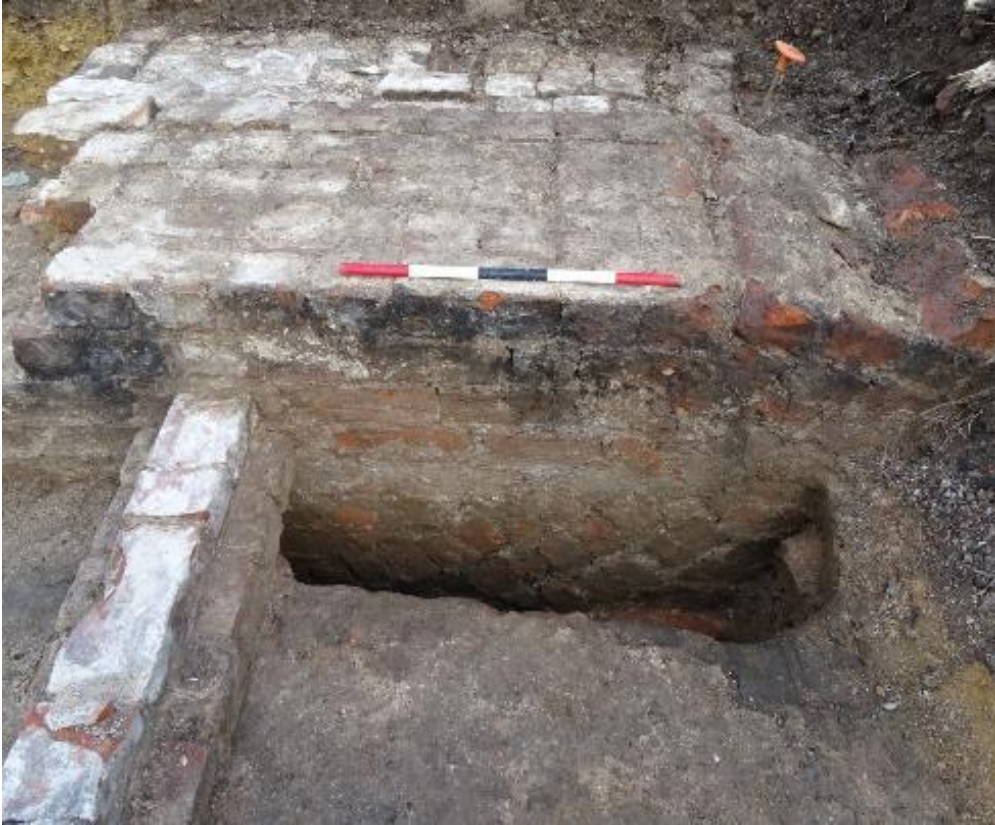
Figure 18: West facing elevation of wall foundation (9) and sleeper walls (15 & 16)

To the west of wall (9) was evidence of three brick built sleeper walls. These walls would

have supported a suspended wooden floor. The sleeper walls were spaced 2m apart (centre to centre) and were aligned east-west.

Sleeper wall (16) measured 2.8m long and was constructed from a single layer of red bricks laid stretcher to stretcher, lightly bonded with a cement. This was directly built onto layer (14).

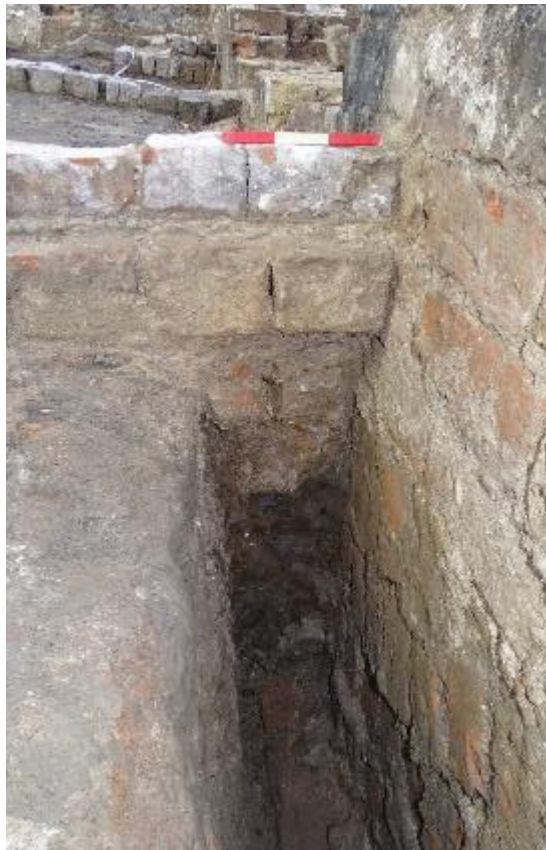
Figure 19: Inverted arch foundation (9) exposed in section, looking east

This type of arched footing were constructed to assist in dispersing the load/weight of the building onto the walls and into the wider ground area, this would create resistance to any inwards or sideways movement. This type of construction has been known to be used on poor ground rather than using extensive foundations. These arches were directly below the window and door openings of the church.

The foundation walls of the church provide an insight in to the early 19th century construction techniques. The inverted arch type of foundation required to create a stable building over poor ground would have required a skilled workforce and would have been more costly to erect than a standard brick foundation construction. The advantage of the inverted arch construction is that in poor ground the depth of the foundation can be greatly reduced as the weight of the structure is distributed along the course of the wall.

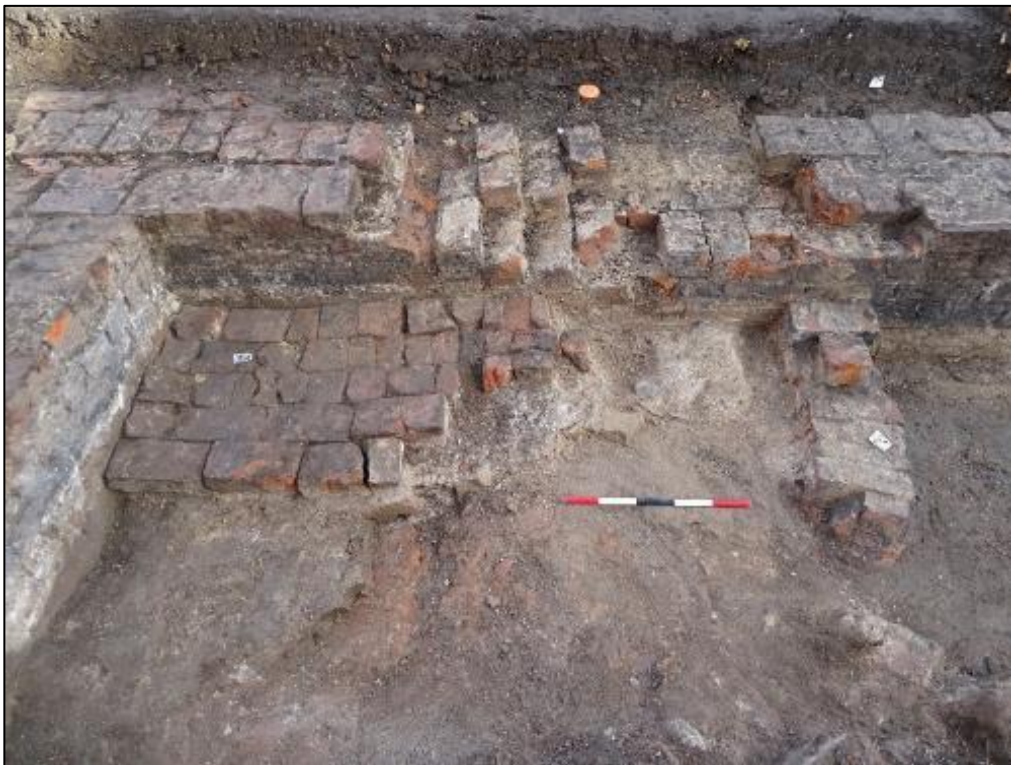
Figure 21: Brick step (19)

To the east of foundation (9) was a layer of bricks cemented with mortar (20: Figure 21) laid stretcher to stretcher, two courses deep, forming the foundation for the former steps for church at the entrance to the building. This deposit was not excavated and left in situ.
