Archaeological Excavation

Low Grange

Daffodil Park

TA22/03

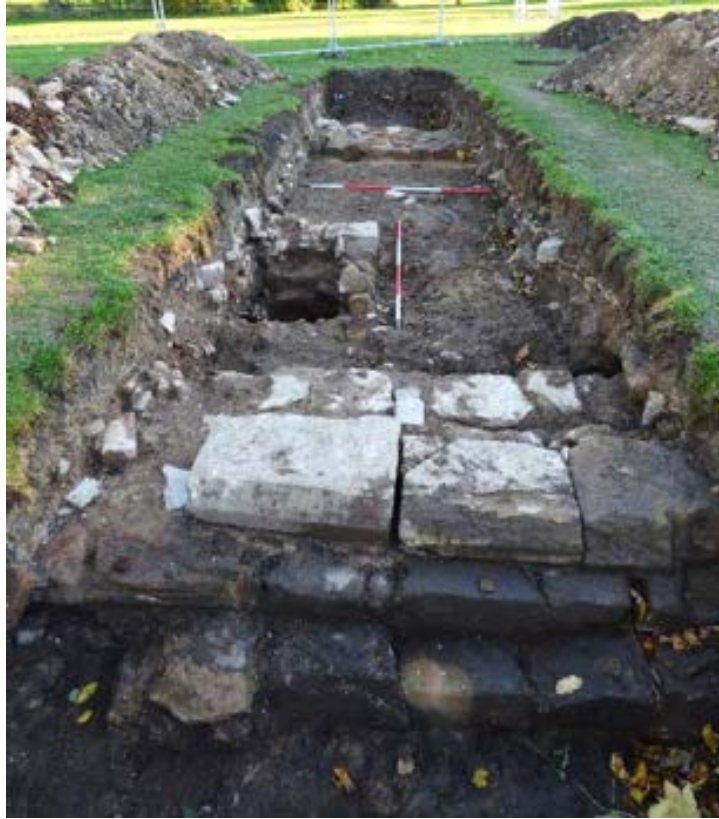
Figure 13: Trench 1 looking south, showing chamfer course on the north wall of the building

An east/west wall foundation (104) was constructed over this deposit in the north part of the trench. This once formed the north facing external wall of a medieval building. The north face of the wall foundation (104) was constructed of large roughly faced stone blocks bonded with lime mortar. The surviving elements of the foundation had a stepped construction projecting out at each lower layer. The projection of the lowest course was 0.2m the next 0.12m topped by a chamfered string of stonework. The wall had a rubble core comprised of medium sized angular stones. The internal face was also stepped and roughly faced although there was no evidence of chamfered stonework as this course had not survived.

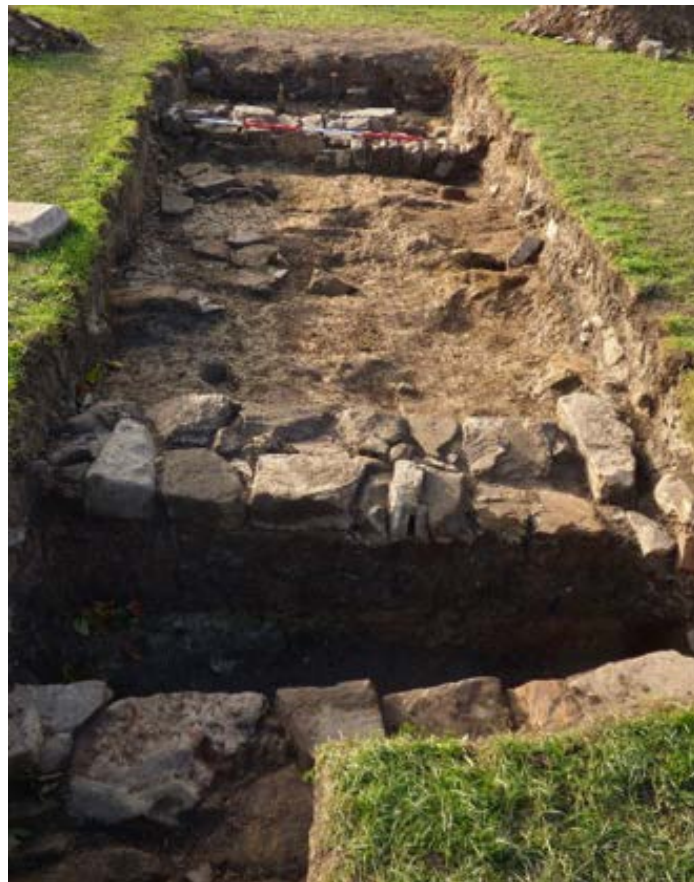
Figure 14: Trench 2 looking east, with earlier wall in the foreground

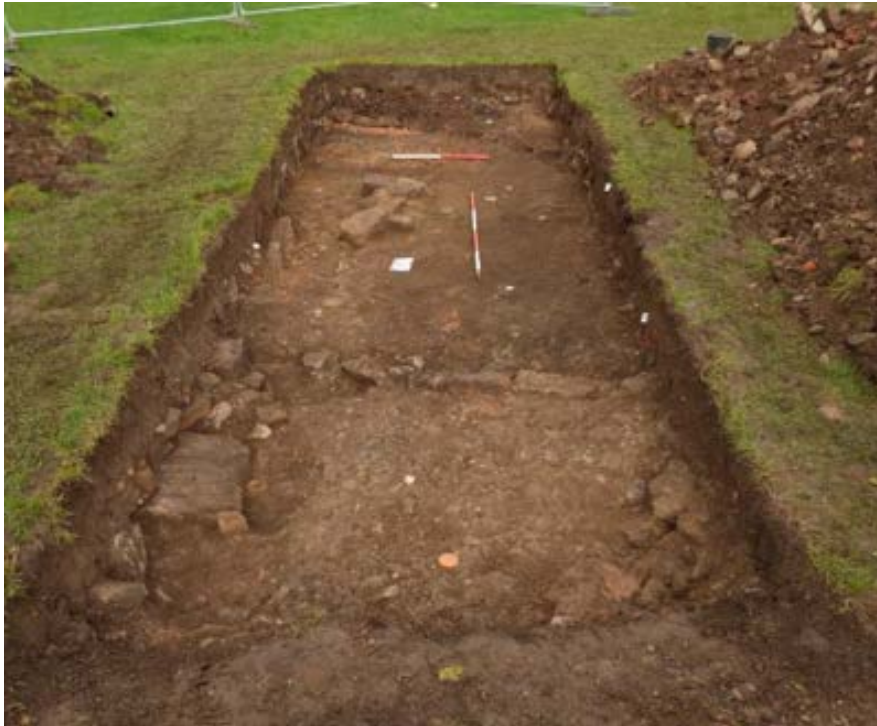
Figure 15: Trench 3 looking north, showing cobbled surface, wall base and entrance to building with wall base

Overlying the back filled drains and clay 331 were cobbled surfaces 312/318 and 313 and a line of stones (310) with associated post-holes. Cobbled surface 312/318 comprised relatively small (0.1m diameter) angular post stones and included fragments of coal. This surface respected the line of stones (310). 310 ran SE to NW and had an east west line of post-holes at its northern end (319, 320, 321, 322 and 323, see table below). At its southern end there was an area of cobbles (313) which was quite distinct from 312/318. 313 comprised a rough surface of quite large water worn cobbles and pieces of undressed stone with pieces of coal.

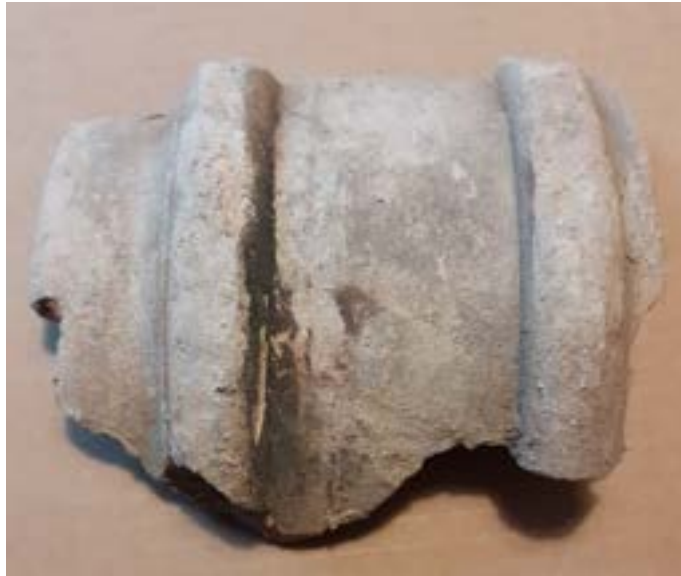
Figure 17: CBM pipe collar of post-medieval date, trench 2, unstratified

The possible exception in date was an unstratified group of hard white pipe pieces, three of which were coated with bitumen and there was a single moulded collar piece with two ribs. This may be of 16th or 17th century date (Figure 17).

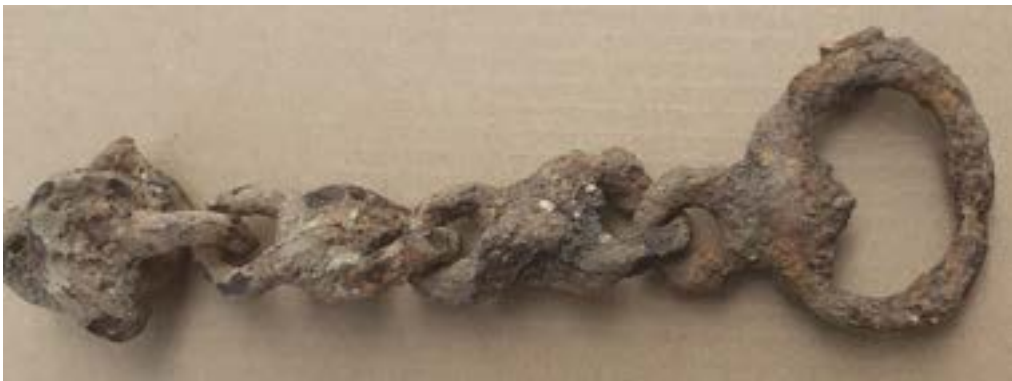
Figure 18: Iron chain horse bit, trench 1, context 112

Iron Chain Bit, with 90mm long chain of figure eight shaped pieces, 20mm across. One of the oval harness fastenings at one end of the chain is intact and measures 20mm across. Probable 19th century date. Trench 1, context 112 (Figure 18).

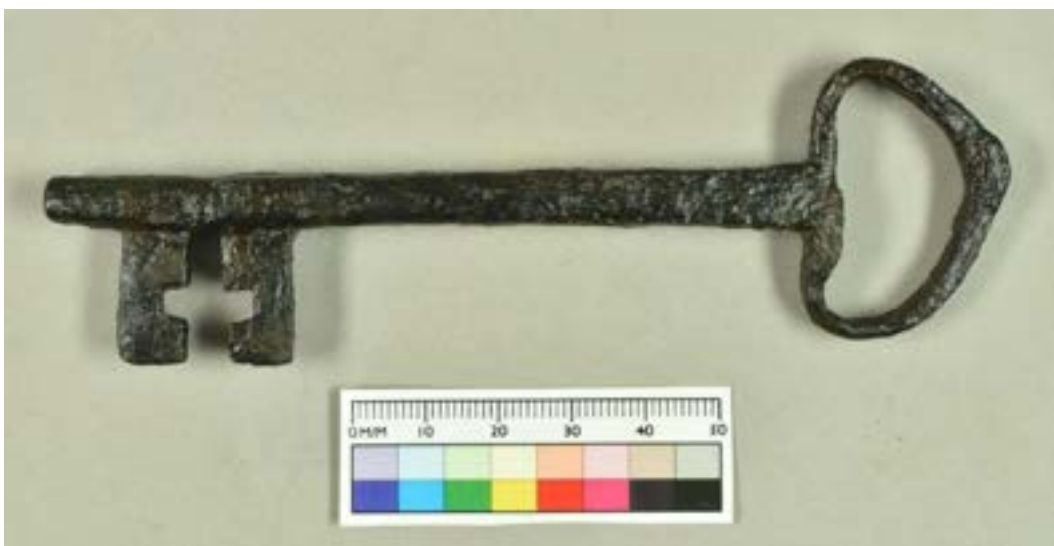
Figure 19: Iron key, trench 2 (© Durham University Artefact Conservation Service)

Iron key with a kidney shaped bow and a square stem until it reaches the bit, when it becomes more cylindrical in shape (Figure 19). The bit consists of two wards which have cut out sections that together form a cross. The key is 129mm overall and the stem is 8 by 8mm at the square section and 6mm diameter at the cylindrical section. The bit is 25 by 24mm, with a depth of 3-4mm, the bow is 37 by 26mm, with a depth of 4mm. Trench 2, context 205.

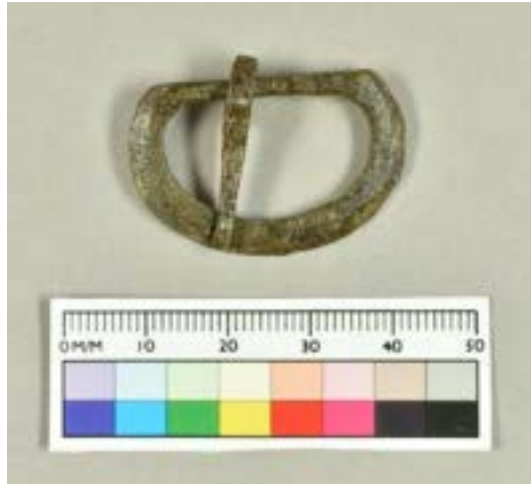
Figure 20: Copper Alloy Buckle, trench 1 (© Durham University Artefact Conservation Service)

'D' shaped buckle with pin, there is a small groove on one side where the pin rests (Figure 21). This type of buckle could either be used with clothing such as belts or with harness and the absence of decoration and any other detail leaves a long date span from the 13th to the 17th centuries. The buckle measures approximately 33mm in length, 22mm in width, and 7mm in depth. Trench 1, context 112.

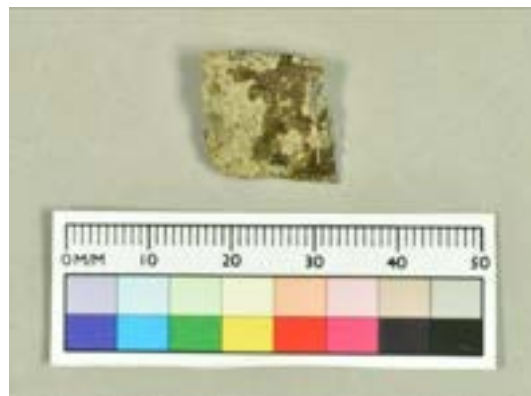
Figure 21: Copper Alloy, lozenge shaped brooch, (© Durham University Artefact Conservation Service)

Lozenge shaped Object. This object has an incised border and there are small triangular indentations around the edges (Figure 22). The 'front' is however badly corroded. There is the remains of a fitting on the reverse which seems to comprise two rectangular pieces of copper alloy. The object measures approximately 15 x 15mm, with a depth of 2mm. Trench 2, context 219, Small Find No 2.

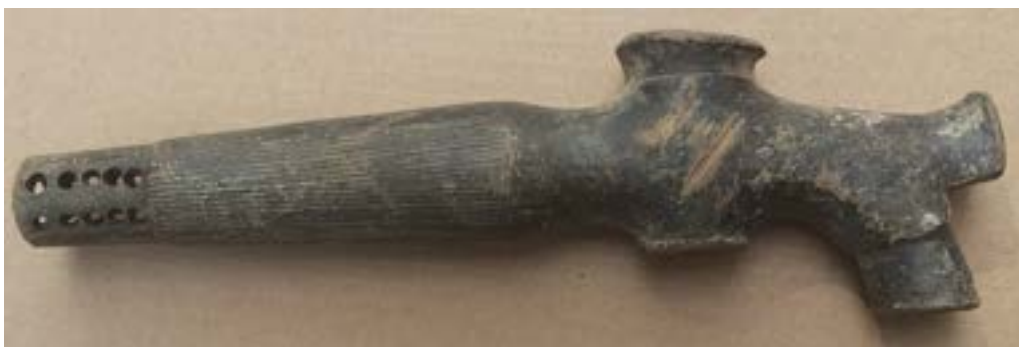
Figure 22: Copper Alloy barrel tap, trench 2, unstratified

Barrel tap spout, the tap is missing, the long end is grooved and has filter holes in it. 159mm long, 20mm wide at tap fitting (Figure 20). Trench 3, unstratified, post-medieval, possibly late 18th century,

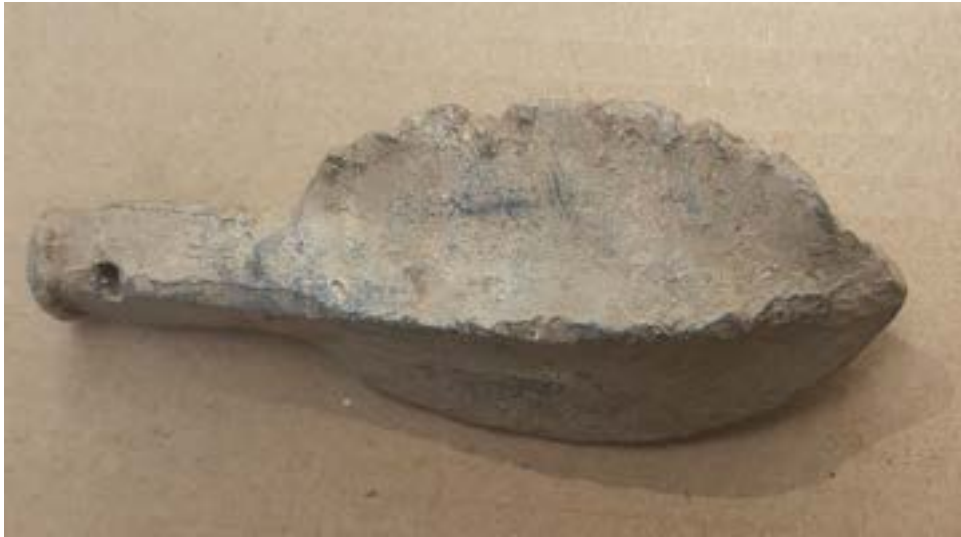
Figure 23: Lead weight, trench 3, unstratified

Lead weight, leaf shaped weight 80mm long and 35mm across at the widest part, with medial ridges and perforation for suspension through the shaft (Figure 23). Possible Plumb Bob. Trench 3, unstratified. Post medieval date.

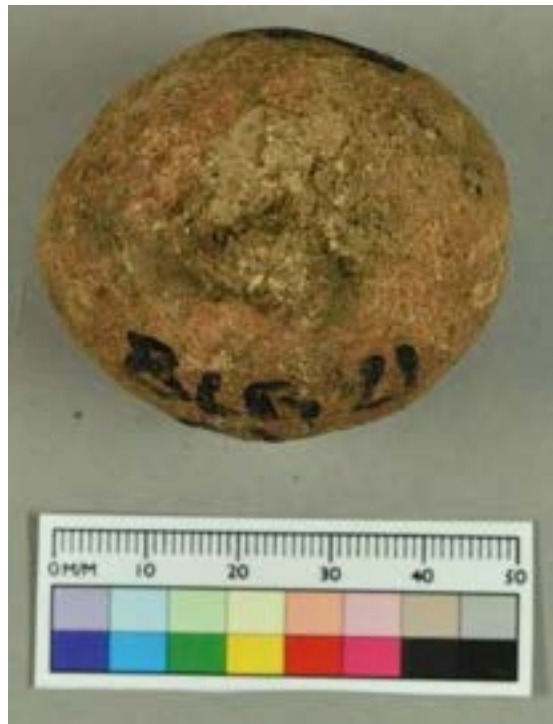
Figure 24: Steelyard weight, trench 1, context 103, (© Durham University Artefact Conservation Service)

Steelyard weight, measures approximately 46mm in length, 41mm in width, and 34mm in depth (Figure 24). Medieval. Trench 1, context 103.

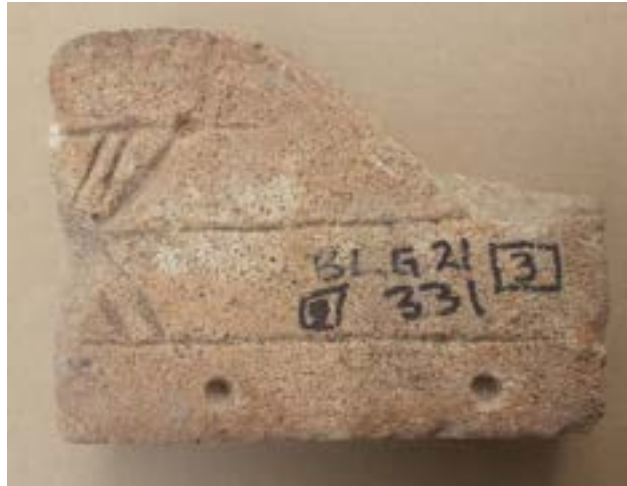
Figure 25: Piece of stone of uncertain use trench 3, context 331

Miscellaneous Stonework. Sandstone with incised lines, arrow design and indentations. Uncertain use and date. Trench 3, context 331 (Figure 25).

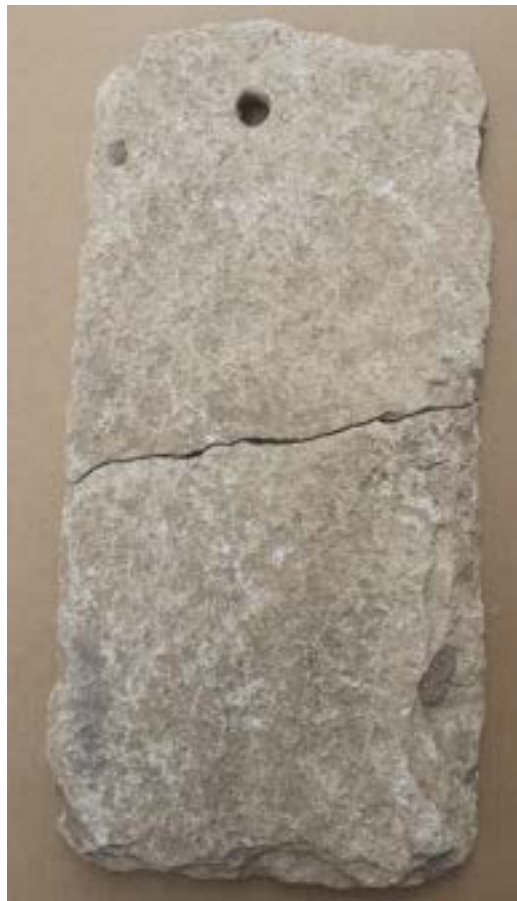
Figure 26: Complete medieval roof tile, trench 1, context 110

Roof tiles. A small number of stone roof tiles of medieval date were found in trenches 1 (4 pieces) and 2 (5 pieces) and this ties in with the medieval origin of the structures encountered in these trenches. The sizes varied but they all had chamfered edges to help the water run off, fixing holes drilled from both sides and mortar on the underside to help fix them in place and make the roof watertight (Figure 26).

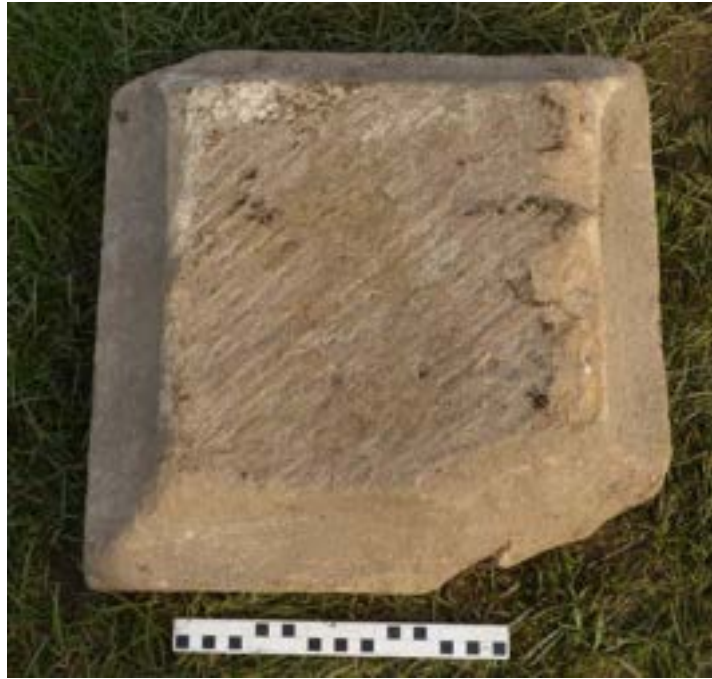
Figure 27: Chamfered plinth, trench 2, small find 3

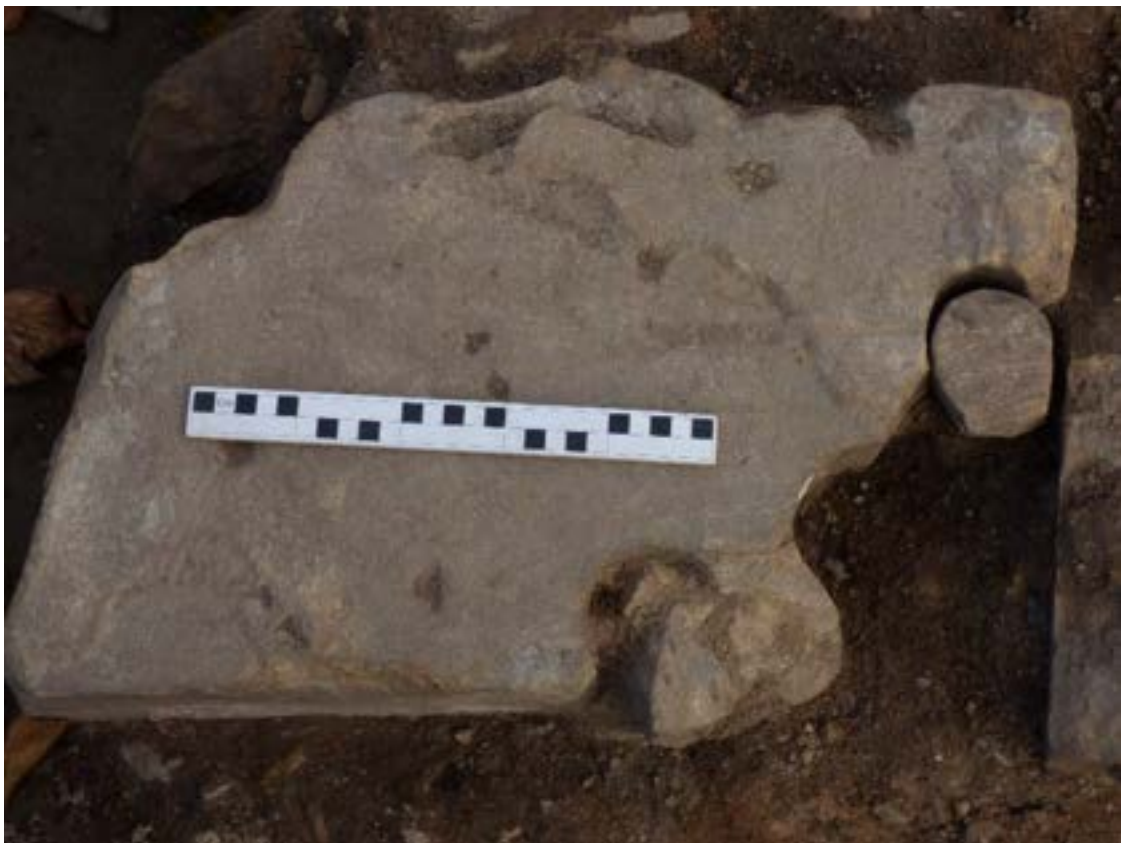
Figure 28: Architectural Stonework with hollows and rolls, trench 2 small find 4

Moulded stone with rolls and hollows. This piece of sandstone measures 0.47m long, 0.31m front to back and 0.27m deep (Figure 28). The hollows are 70mm in diameter. There are two roll mouldings with adjoining hollows. The rolls have been broken off and have been placed in the hollows. There are rough dressings top and bottom to allow keying of mortar. This is a section of arcading of probable 13th century date which lies to the exterior of the building in trench 2. This has been left 'in situ'. Trench 2, context 211, small find 4

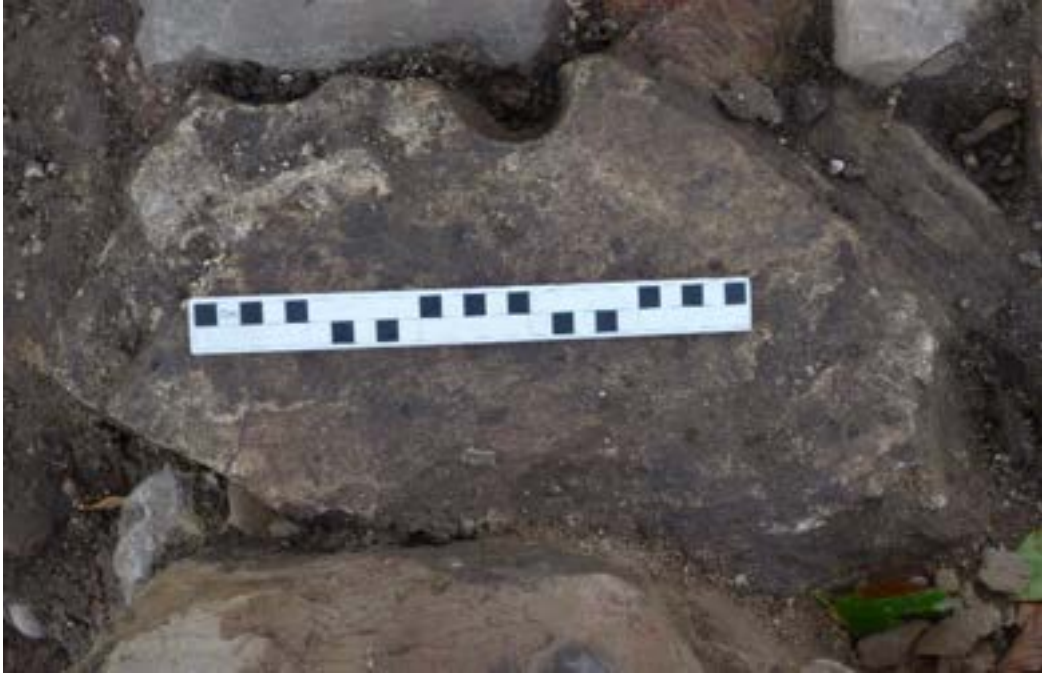
Figure 29: Architectural Stonework with hollows and rolls, trench 2 small find 6

Moulded stone with two hollows. This piece of sandstone measures 0.41m long, 0.23m front to back and is at least 0.55m deep although the bottom was not visible. There are two adjacent hollows of 60mm diameter and there would have been a moulding between the two hollows but this has broken off. This is probably a piece of arcading and the absence of the mouldings makes dating uncertain there seems little reason to doubt that it would have had roll mouldings as in small find 4. Trench 2, context 209, small find 6.

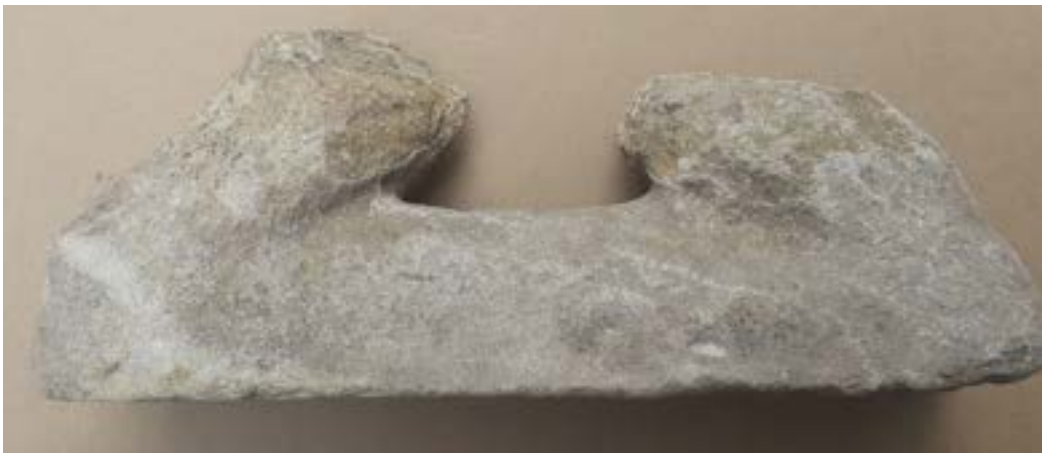
Figure 30: Moulded stone, medieval tracery, trench 2, context 205

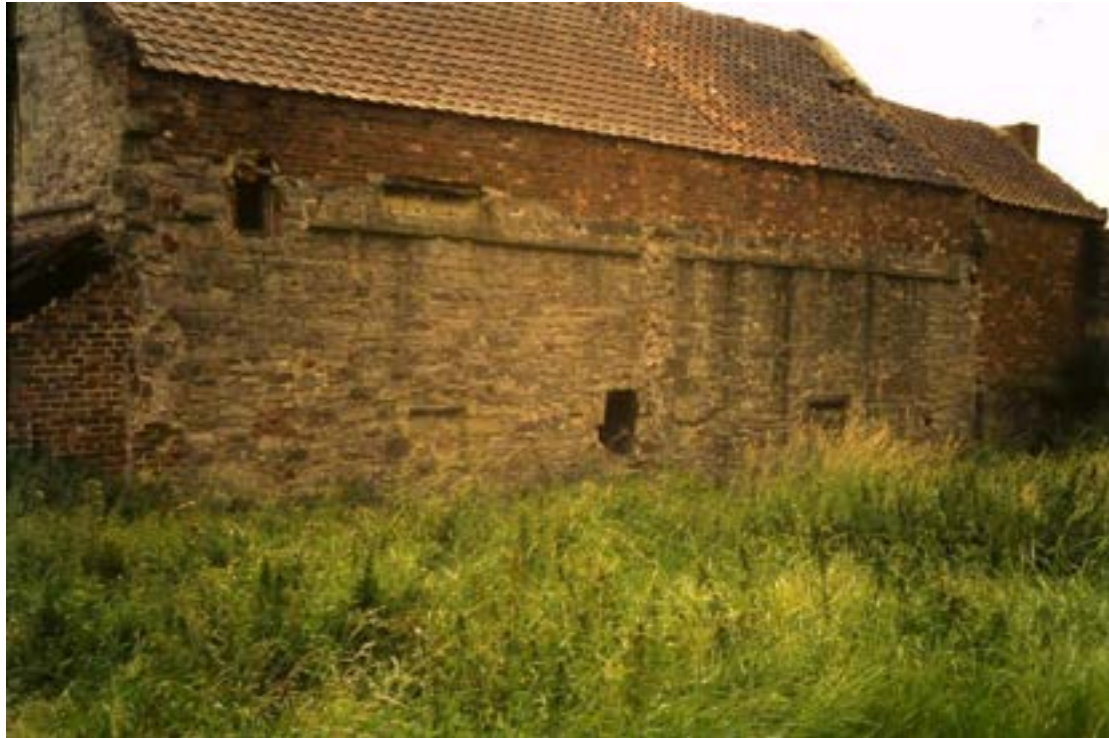
Figure 31: North wall of building in trench 1, c. 1960 (L Still)

Externally the **north wall** had a chamfered plinth just above its foundation (revealed by excavation) and at the top of the wall, about 3.6m (12ft) above the plinth, there was a chamfered string course. Both plinth and string course were missing where corner and central buttresses were once attached. The elevation was largely blank apart from two small oblong windows with chamfered ashlar dressings, now blocked, that once lit the ground floor. Just above the string course was the base of a two-light mullioned window, also dressed in ashlar, which must have risen above eaves level. The dressed stone kneeler on the northern corner of the medieval east gable survived, embedded in later brickwork.

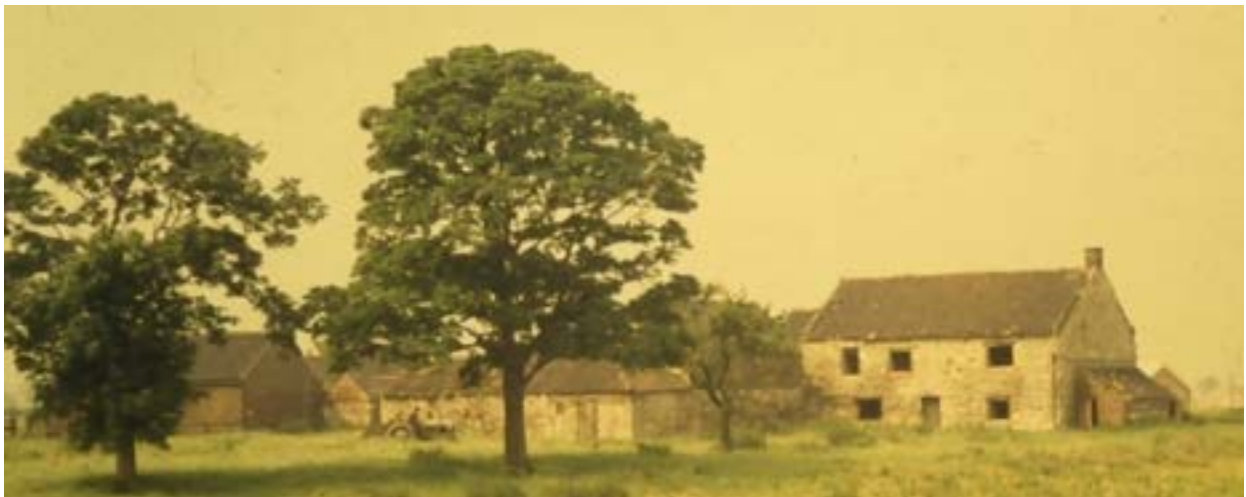
Figure 32: General view of farm complex in c. 1960, from the south. Large building is that excavated in trench 1, smaller building to the west is that excavated in trench 2 (L Still)

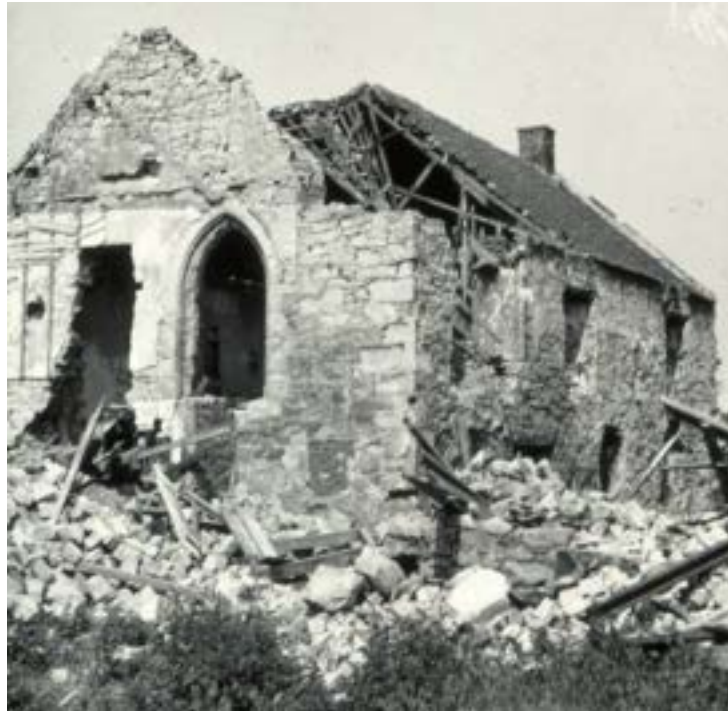
Figure 33: The farmhouse from the south-west during demolition in the early 1960s

The early 1960s photograph of the part-demolished Low Grange farmhouse is an arresting image (Figure 33). Clearly revealed in its end gable is a large arched opening of medieval date. By good fortune the farmhouse was photographed, the surrounding area excavated and its wider landscape surveyed, all by Leslie Still and colleagues. So we have, at least, 'preservation by record'.

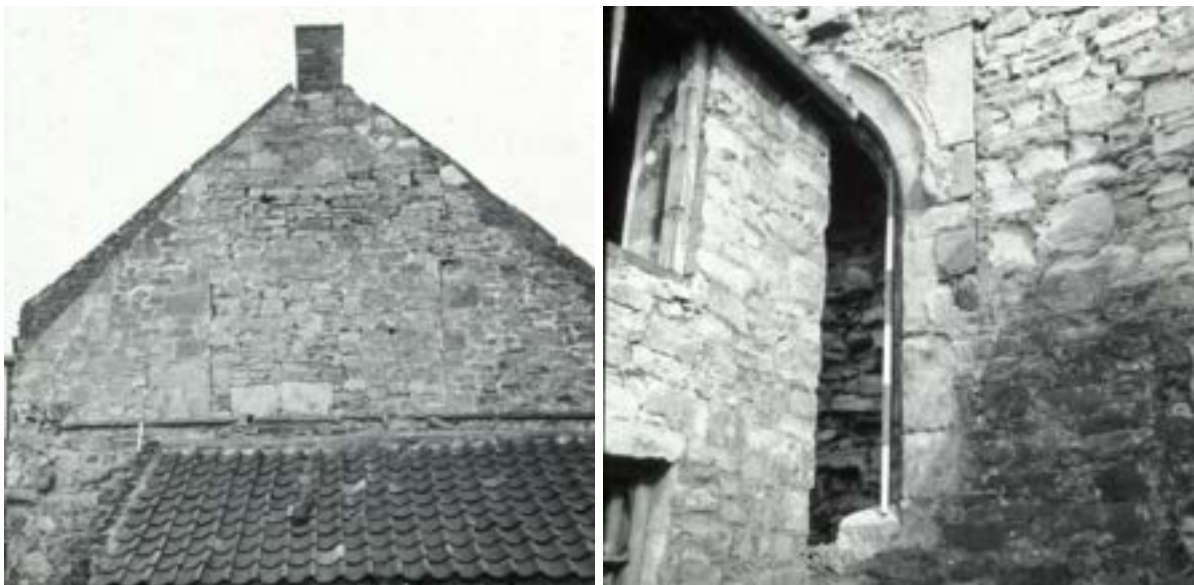
Figure. 34: (a) East gable showing raised and trimmed gable and blocked east window. (b) Blocked doorway in west gable before demolition of adjacent farm building. Also showing dressed quoins to the right of the doorway arch.

The **east wall** had a chamfered plinth and string course, the plinth missing where there were once buttresses, and a single ground floor window like those on the north wall. Immediately above the string course was a large, blocked window opening with ashlar dressings 2.7m (9ft) wide.

The **west wall** had the usual chamfered plinth, and at ground level at the northern end was a blocked doorway, double chamfered ashlar dressings with one surviving voussoir from its arch springing. It was splayed to the rear. At first floor level, at the southern end of the wall, was a large medieval arched opening with a similar double chamfered ashlar surround, measuring 2.29 x 1.15 m (7ft 6 in x 3ft 8 in), also splayed to the rear. Still interprets this as a window, also noting the presence of stumps of two metal saddle bars in the jambs. However, there is no evidence of any missing mullions or tracery, and taken with its offset position in the wall, its overall appearance and similarity to the ground floor doorway with its double chamfered jambs strongly suggest it is a first-floor doorway. The base of the opening also lines up with the blocked door threshold in the adjacent south wall. This is convincing evidence for the opening being a doorway and might also reinterpret Still's metalwork in the jambs as the remains of latches and catches. To the right (south) of the doorway arch is an unusual section of dressed quoins which might suggest the wall here abutted an existing building.

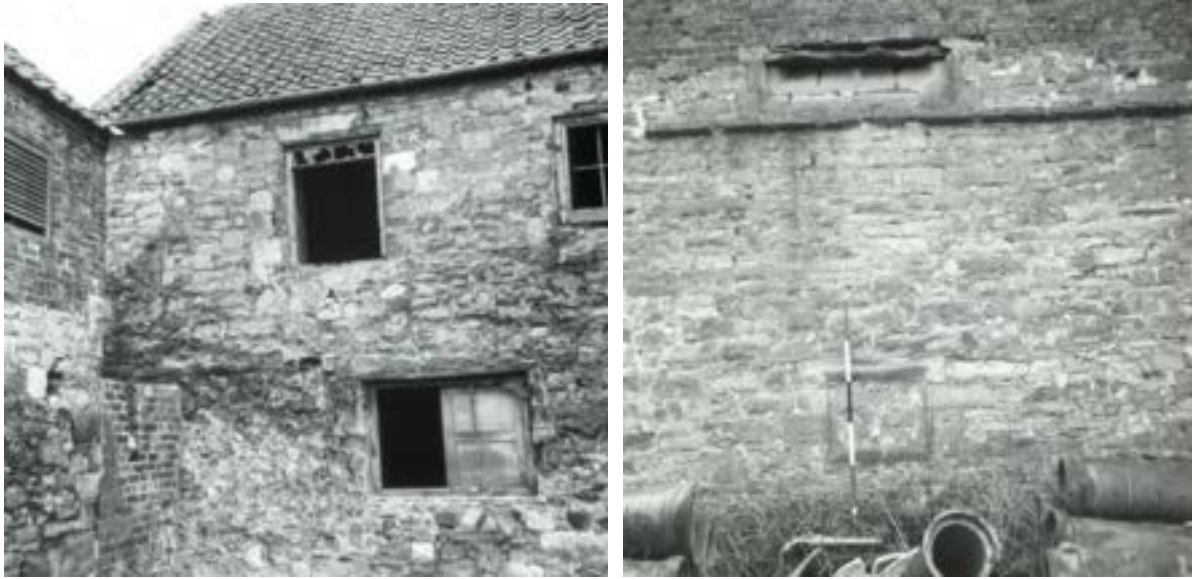
Figure 35: (a) The south side of the farmhouse, at the west end. Note the blocked first floor doorway, and the faceless stonework below. (b) The central section of the north wall, showing the small ground floor window, the string course, and the base of the two-light dormer window.

The **south wall** had five post-medieval windows and a doorway. The plinth was revealed by excavation. There are areas of ground floor stonework at the west end that lack any discernible face. Above this area was a blocked first floor doorway with ashlar stone dressings, missing its arched head.

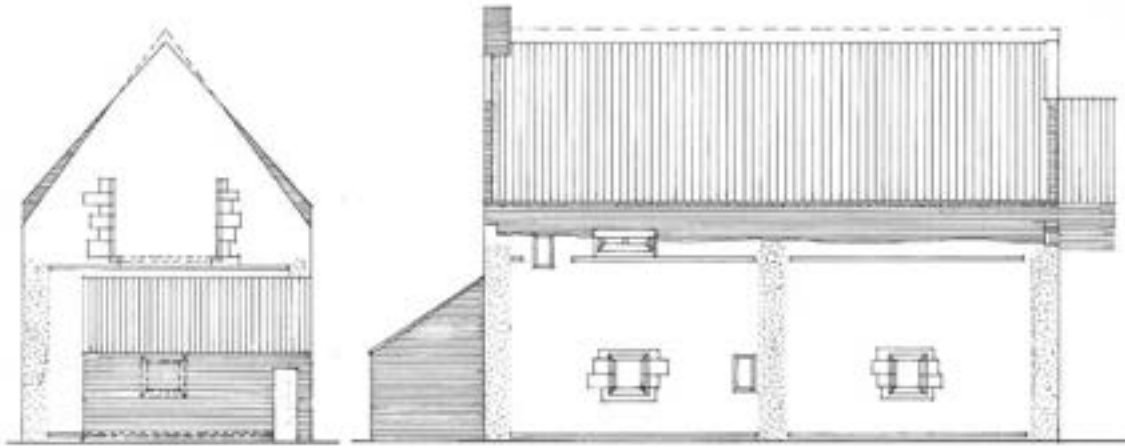
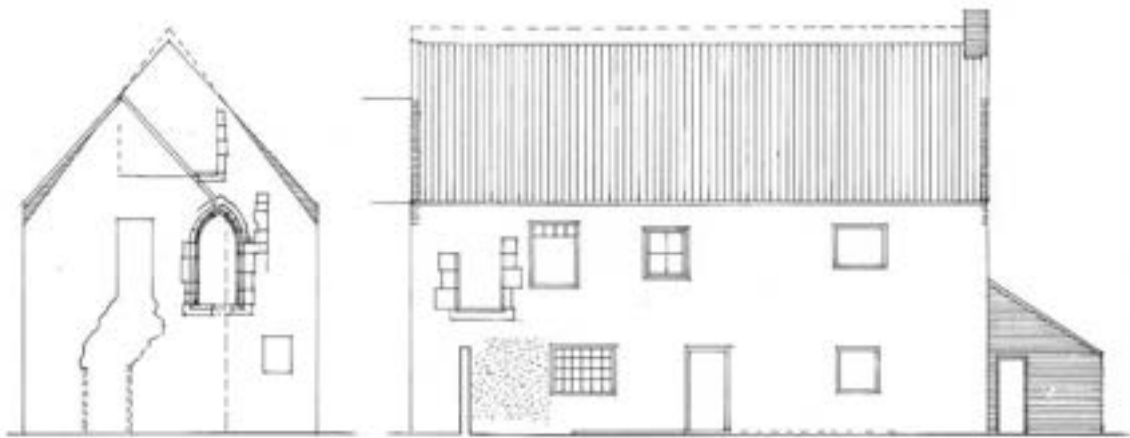
Figure 37: Prior's lodgings, Bewley. Elevations. East and north (above), west and south (below) (© Martin Roberts)
